REPORT

Sjø 2009/04

REPORT ON INVESTIGATION OF OCCUPATIONAL ACCIDENT ON BOARD MV NORDSTAR - LHXV NORTHWEST OF MÅLØY 7. OCTOBER 2008

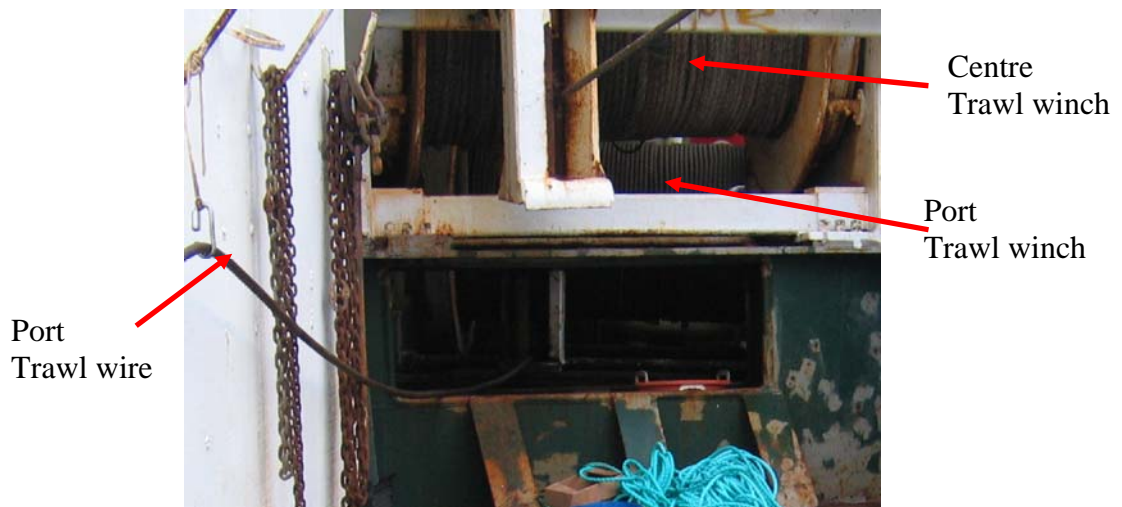
Figure 4: Port side trawl winch.

All the winches are operated from the same panel aft in the wheelhouse, see figure 4. The winch operator (normally the skipper/mate) has a good view astern from this position. Due to the location of the wheelhouse, however, it is not possible to see all parts of the quarterdeck from this position. The winch operator is therefore dependent on visual contact with the trawl boss down on the deck, who by using signs can assist in directing the operation.

The manoeuvring panel for the winches is located against the aft bulkhead in the wheelhouse. The operator stands in front of the panel facing aft with a good overview of the aft deck and the trawl alley. The operating levers for the winches are clearly marked SB, S and BB, respectively, see Figures 4 and 5. The operating levers on the panel are located so that the lever for operating the starboard winch is actually located to starboard of the lever for operating the port winch, and vice versa. Since the operator stands facing aft, the operating lever for the port winch will be located to the right of the operating lever for the starboard winch, and vice versa. The operating levers are located 5-7 cm from each other, which makes it possible to pull the wrong lever if one is inattentive.
