THE AIRCRAFT ACCIDENT INVESTIGATION BOARD / NORWAY

HAV 02/93

**REPORT ON THE CONVAIR 340/580 LN-PAA AIRCRAFT
ACCIDENT NORTH OF HIRTSHALS, DENMARK, ON
SEPTEMBER 8, 1989**

SUBMITTED FEBRUARY 1993

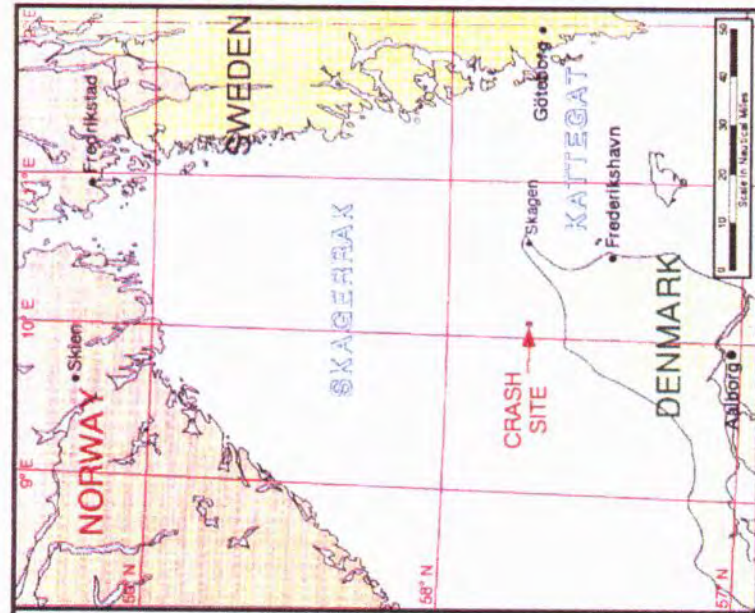
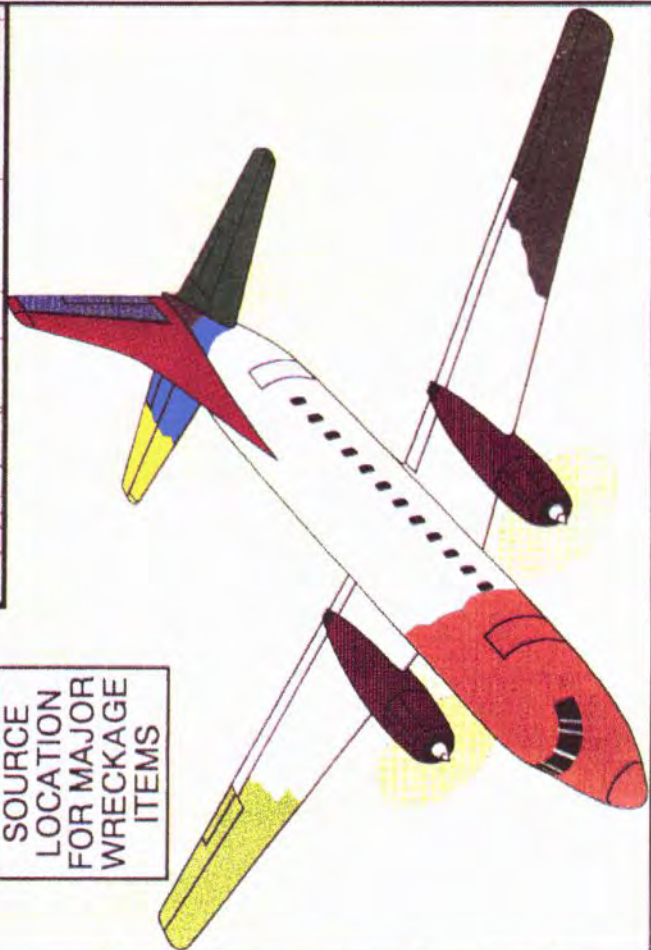
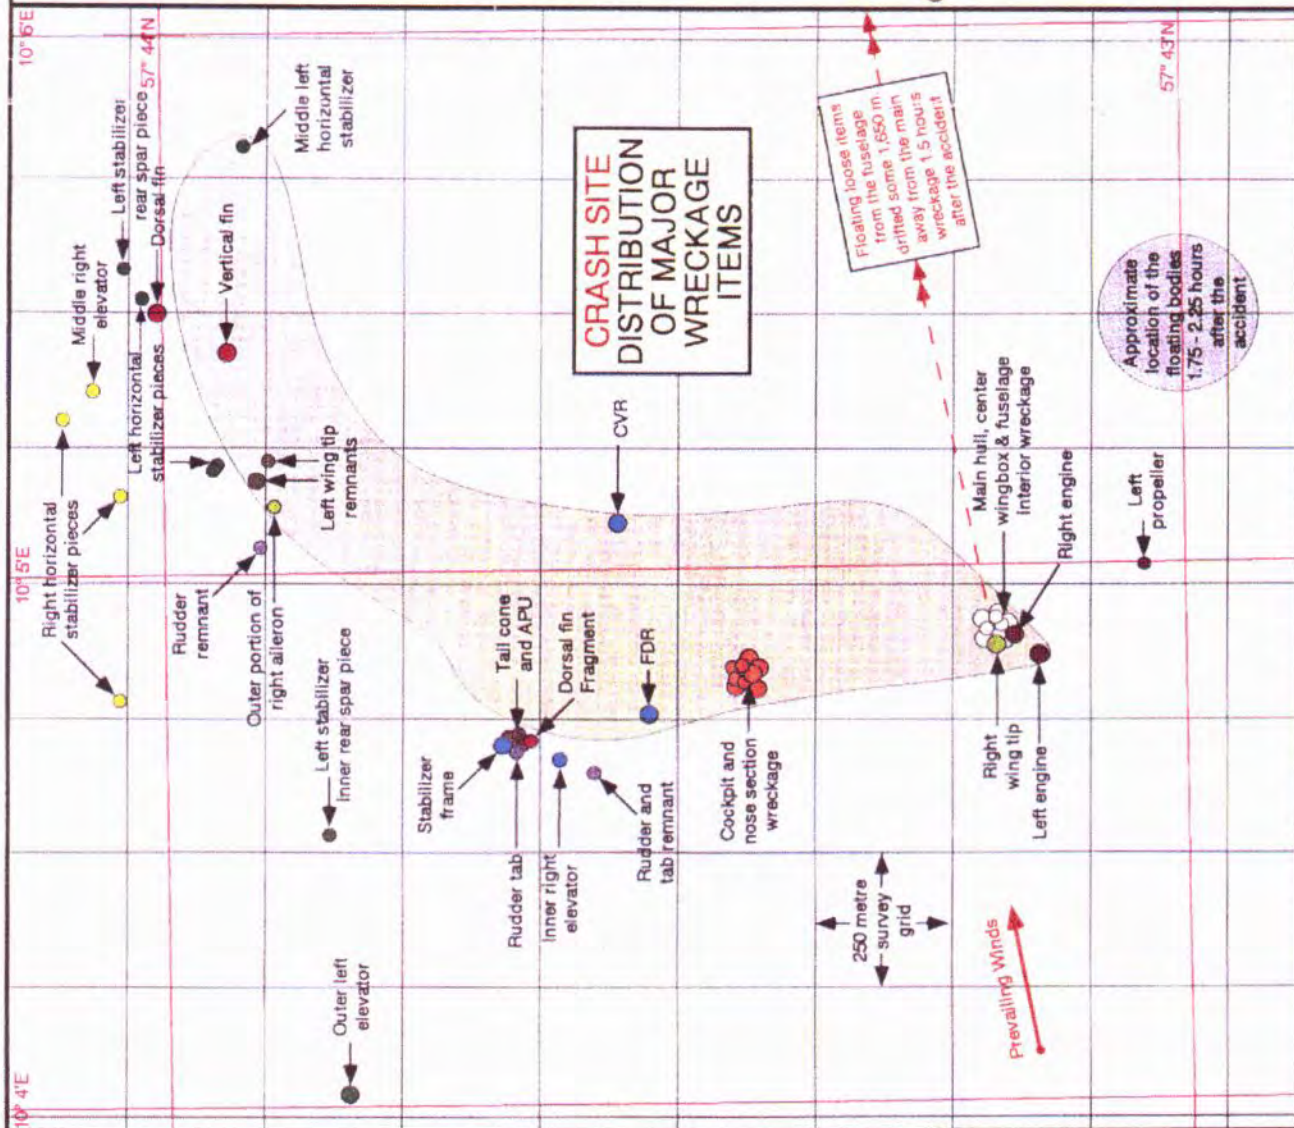
FIG. 2

1.12.1.1 The site of the accident was at sea, approximately 10 nm north of Hirtshals (figure 2). The location of the start of the search was based on radar information received and on the position of floating victims and wreckage. A side-scanning sonar was used to search the sea bed. Approximately 52 km² of the sea bed was searched with 100% overlapping. The area where the wreckage was found was limited to approximately 12.5 km². The main wreckage area covered approximately 3 km².

1.12.1.2.6 After the salvaging operation had been completed the positions of the wreckage parts were plotted on suitable maps. The positions of the essential parts are shown in figure 2.

WRECKAGE DISTRIBUTION ANALYSIS PARTNAIR CONQAIR 580, LN-PAA

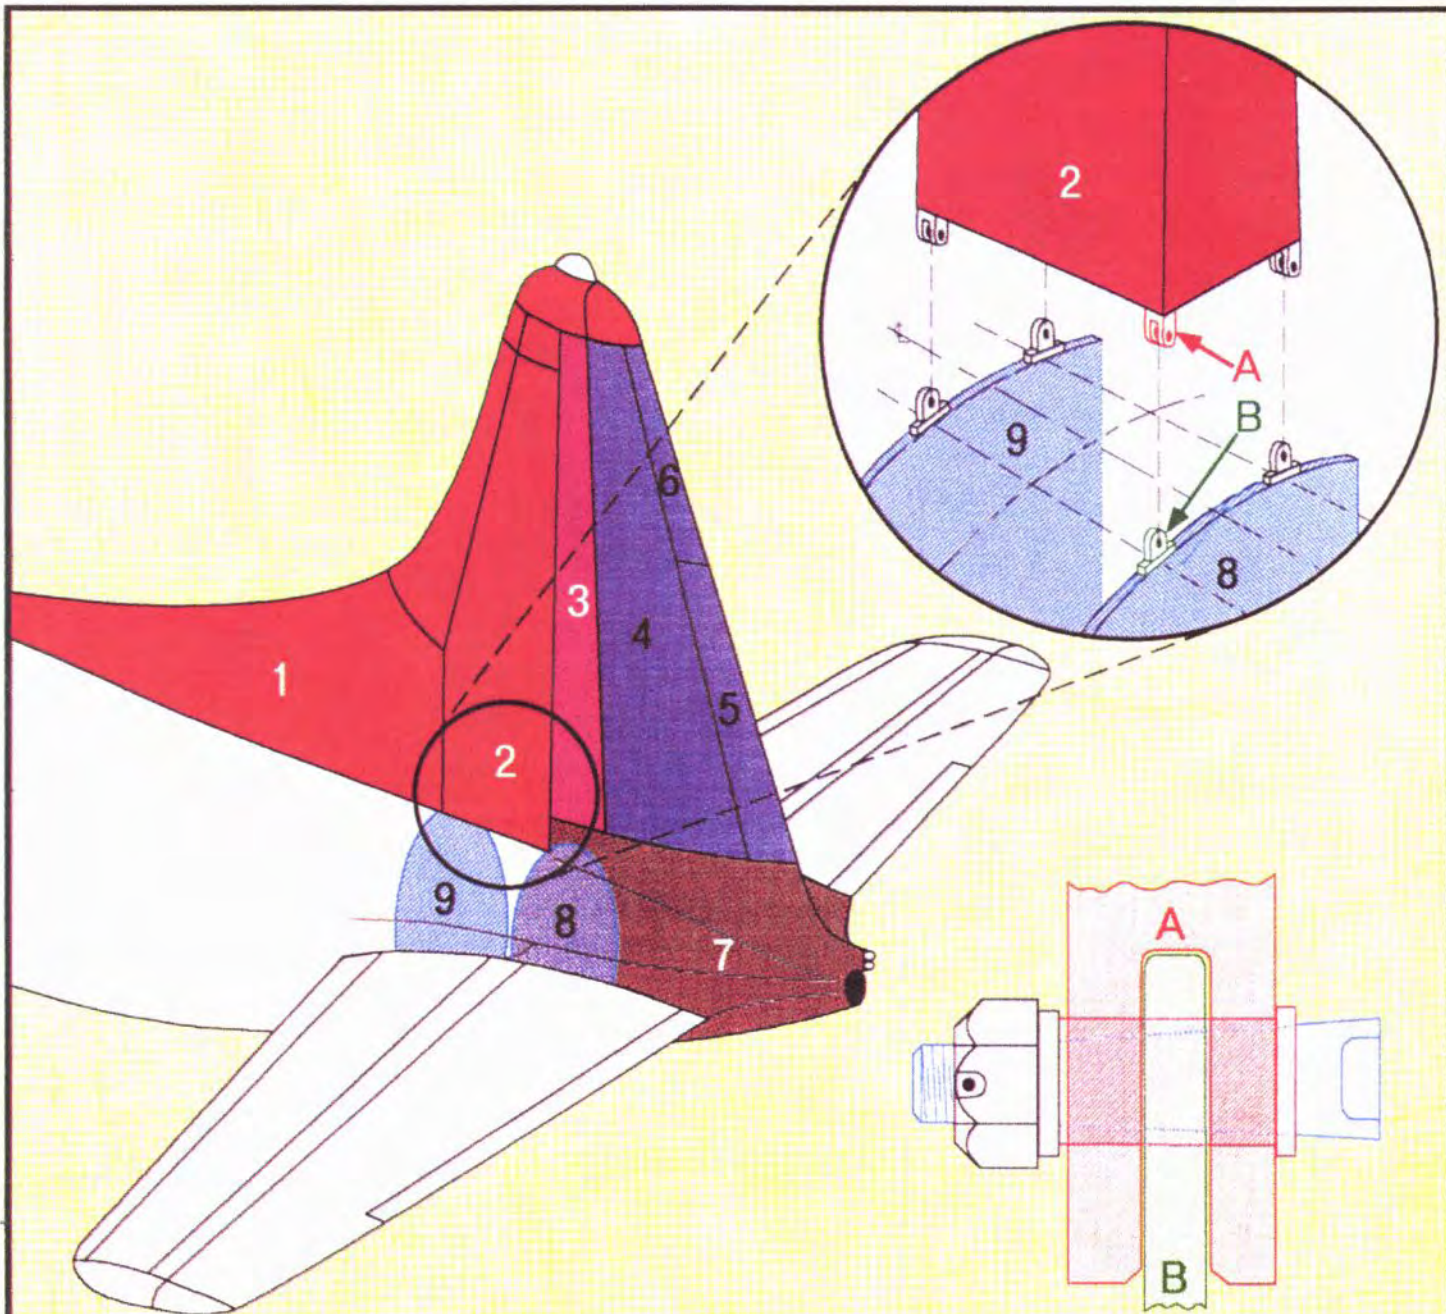
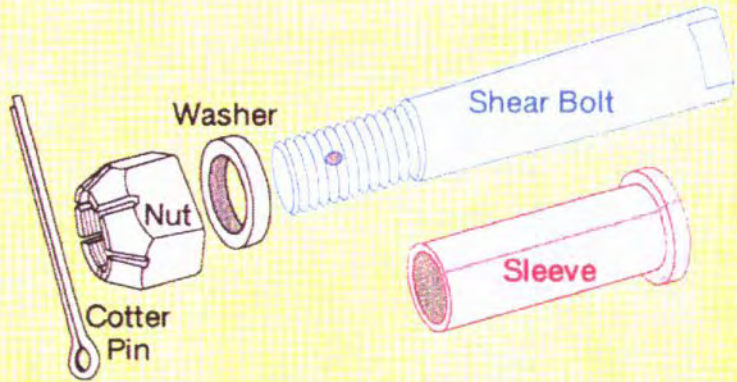
FIG. 3

bracket had two lugs fitted on either side of a steel bracket lug (figure 3). Both types of brackets may be equipped with inside steel bushings. On this aircraft only the aluminum brackets were fitted with such bushings. The fastening bolt consisted of a conical steel pin with a matching steel sleeve. The inside of the sleeve had a conical shape corresponding to that of the pin. The external shape was cylindrical. In addition, the sleeve had a longitudinal slit facilitating expansion when the pin was drawn into the sleeve. The purpose of this design was to provide a tight fitting for the attachment, thereby eliminating all movement when connecting the fin to the fuselage.

Later examinations by AIR also revealed that the two front attachment pins, as well as their respective sleeves, did not satisfy the specifications. The hardness was between 200 and 230 (HV5). A hardness of 200 - 230 corresponds to a tensile strength of approximately 100,000 psi. Convair's specification for hardness corresponds to a tensile strength of 160,000 to 180,000 psi.

**TAIL & FIN ATTACHMENT SKETCH
PARTNAIR CONVAIR 580, LN-PAA**

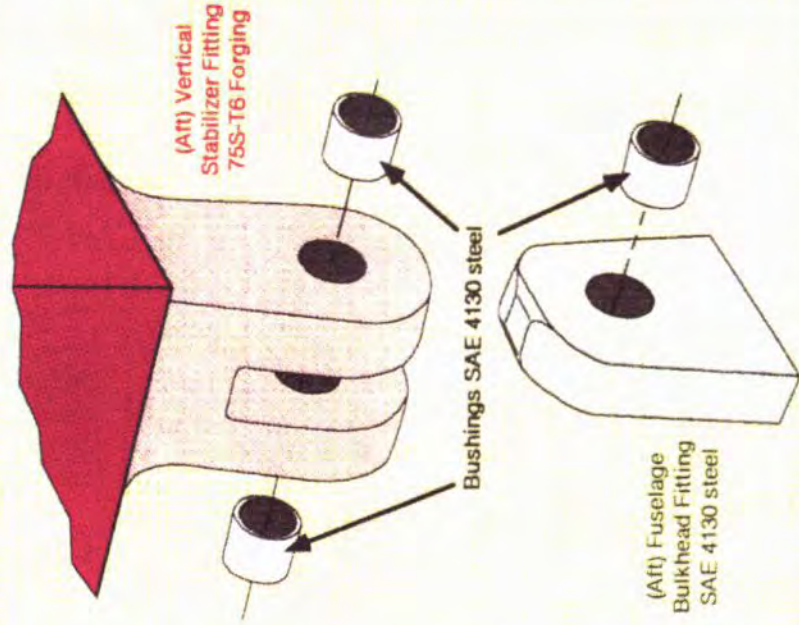
FIG. 4 VERTICAL STABILIZER BUSHING & SLEEVE DIMENSIONS & SPECIFICATIONS SKETCH; PARTNAIR CONVAIR 580, LN-PAA

A check carried out on the bushings installed in the aluminum lugs on the rear right-hand attachment bracket showed a considerable discrepancy between the dimensions in the front and rear bushings. The difference between the outer diameters was approximately 0.013 inches while the difference between the inner diameters was approximately 0.018 inches (figure 4). In the production of these bushings the maximum allowable deviation is 0.001 inches.

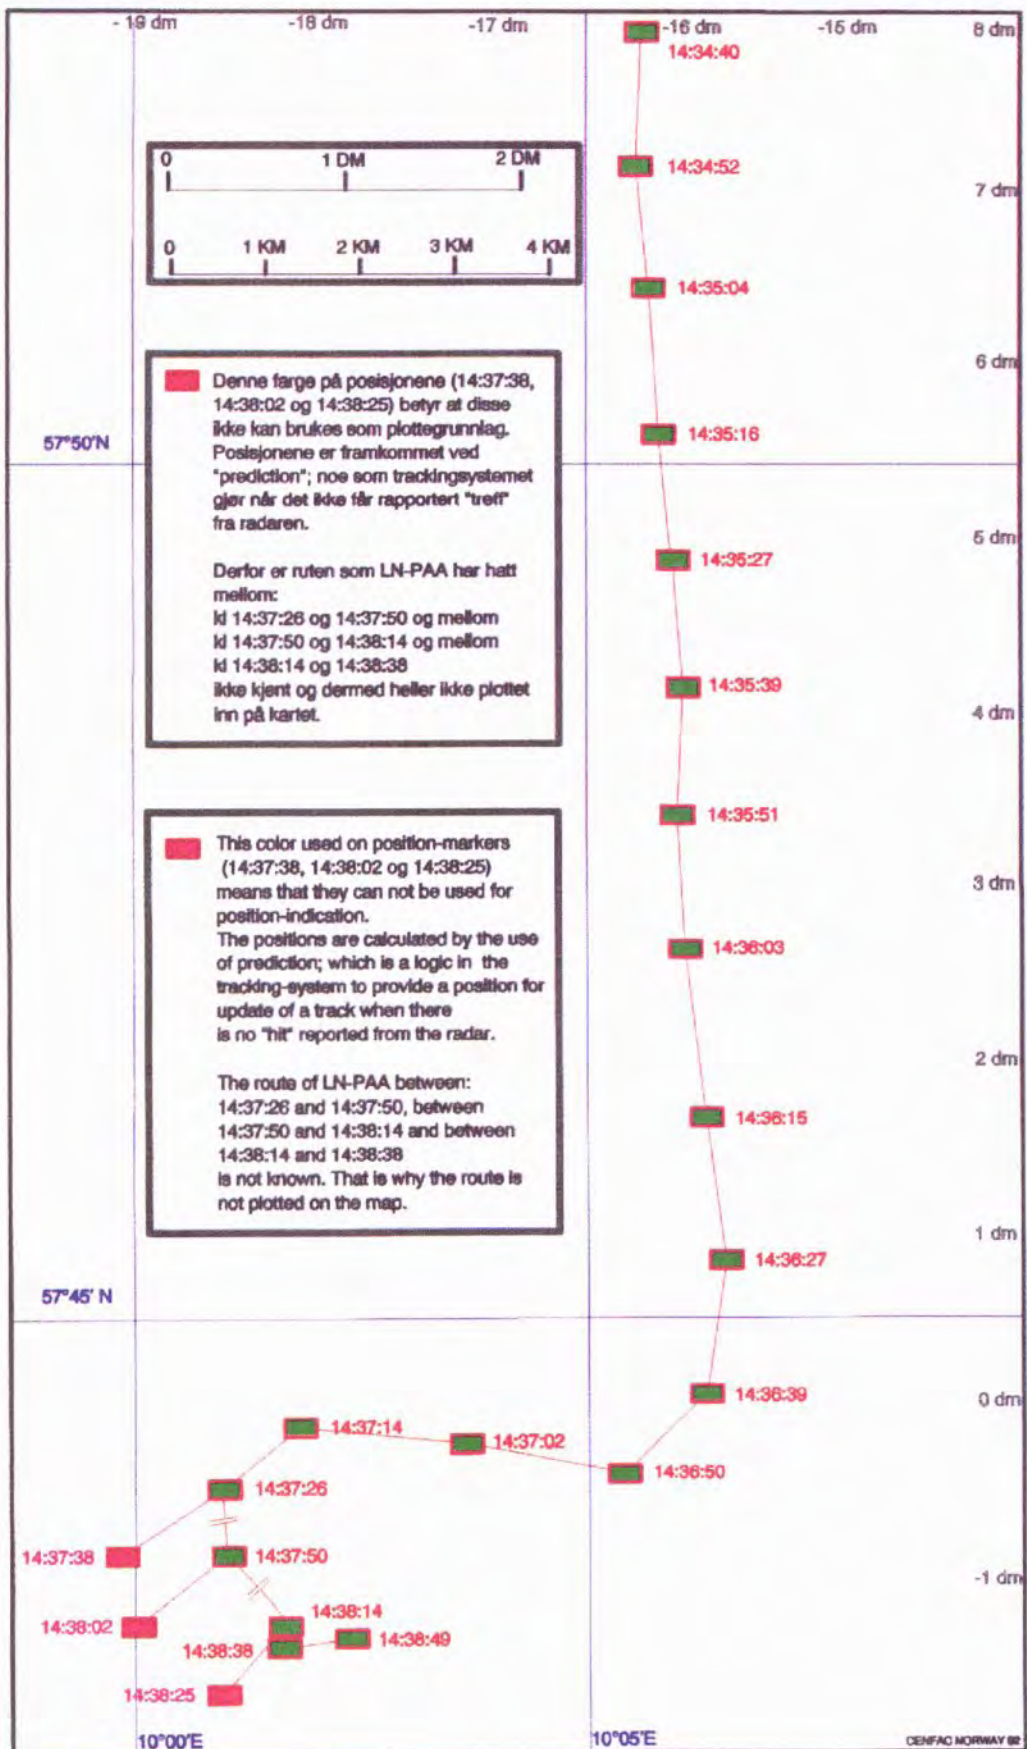
FIG. 6

been any wider, as figure 6 shows, owing to the characteristics of the radar system. The last recording of acceptable quality was made at 1438:49 hrs. The last recording by AWACS was made at 1438:08 hrs. At 1437:43 Swedish radar monitored LN-PAA for the last time. The radar recording ended abruptly on the Swedish radar screen, which, according to Swedish experts, indicated a steep descent.

According to the Norwegian system consultant, the monitoring of the aircraft track by Skagen radar was the most accurate. The Board therefore chose to go by Skagen radar's recordings (figure 6).

From 1428:00 hrs to 1432:36 hrs there were several recordings of 21,900 ft. Twenty seconds later the mode C recording was 21,800 ft. There was a subsequent interval until 1438:03 hrs, when the final recording was made. The altitude of the aircraft was then given as 11,200 ft.

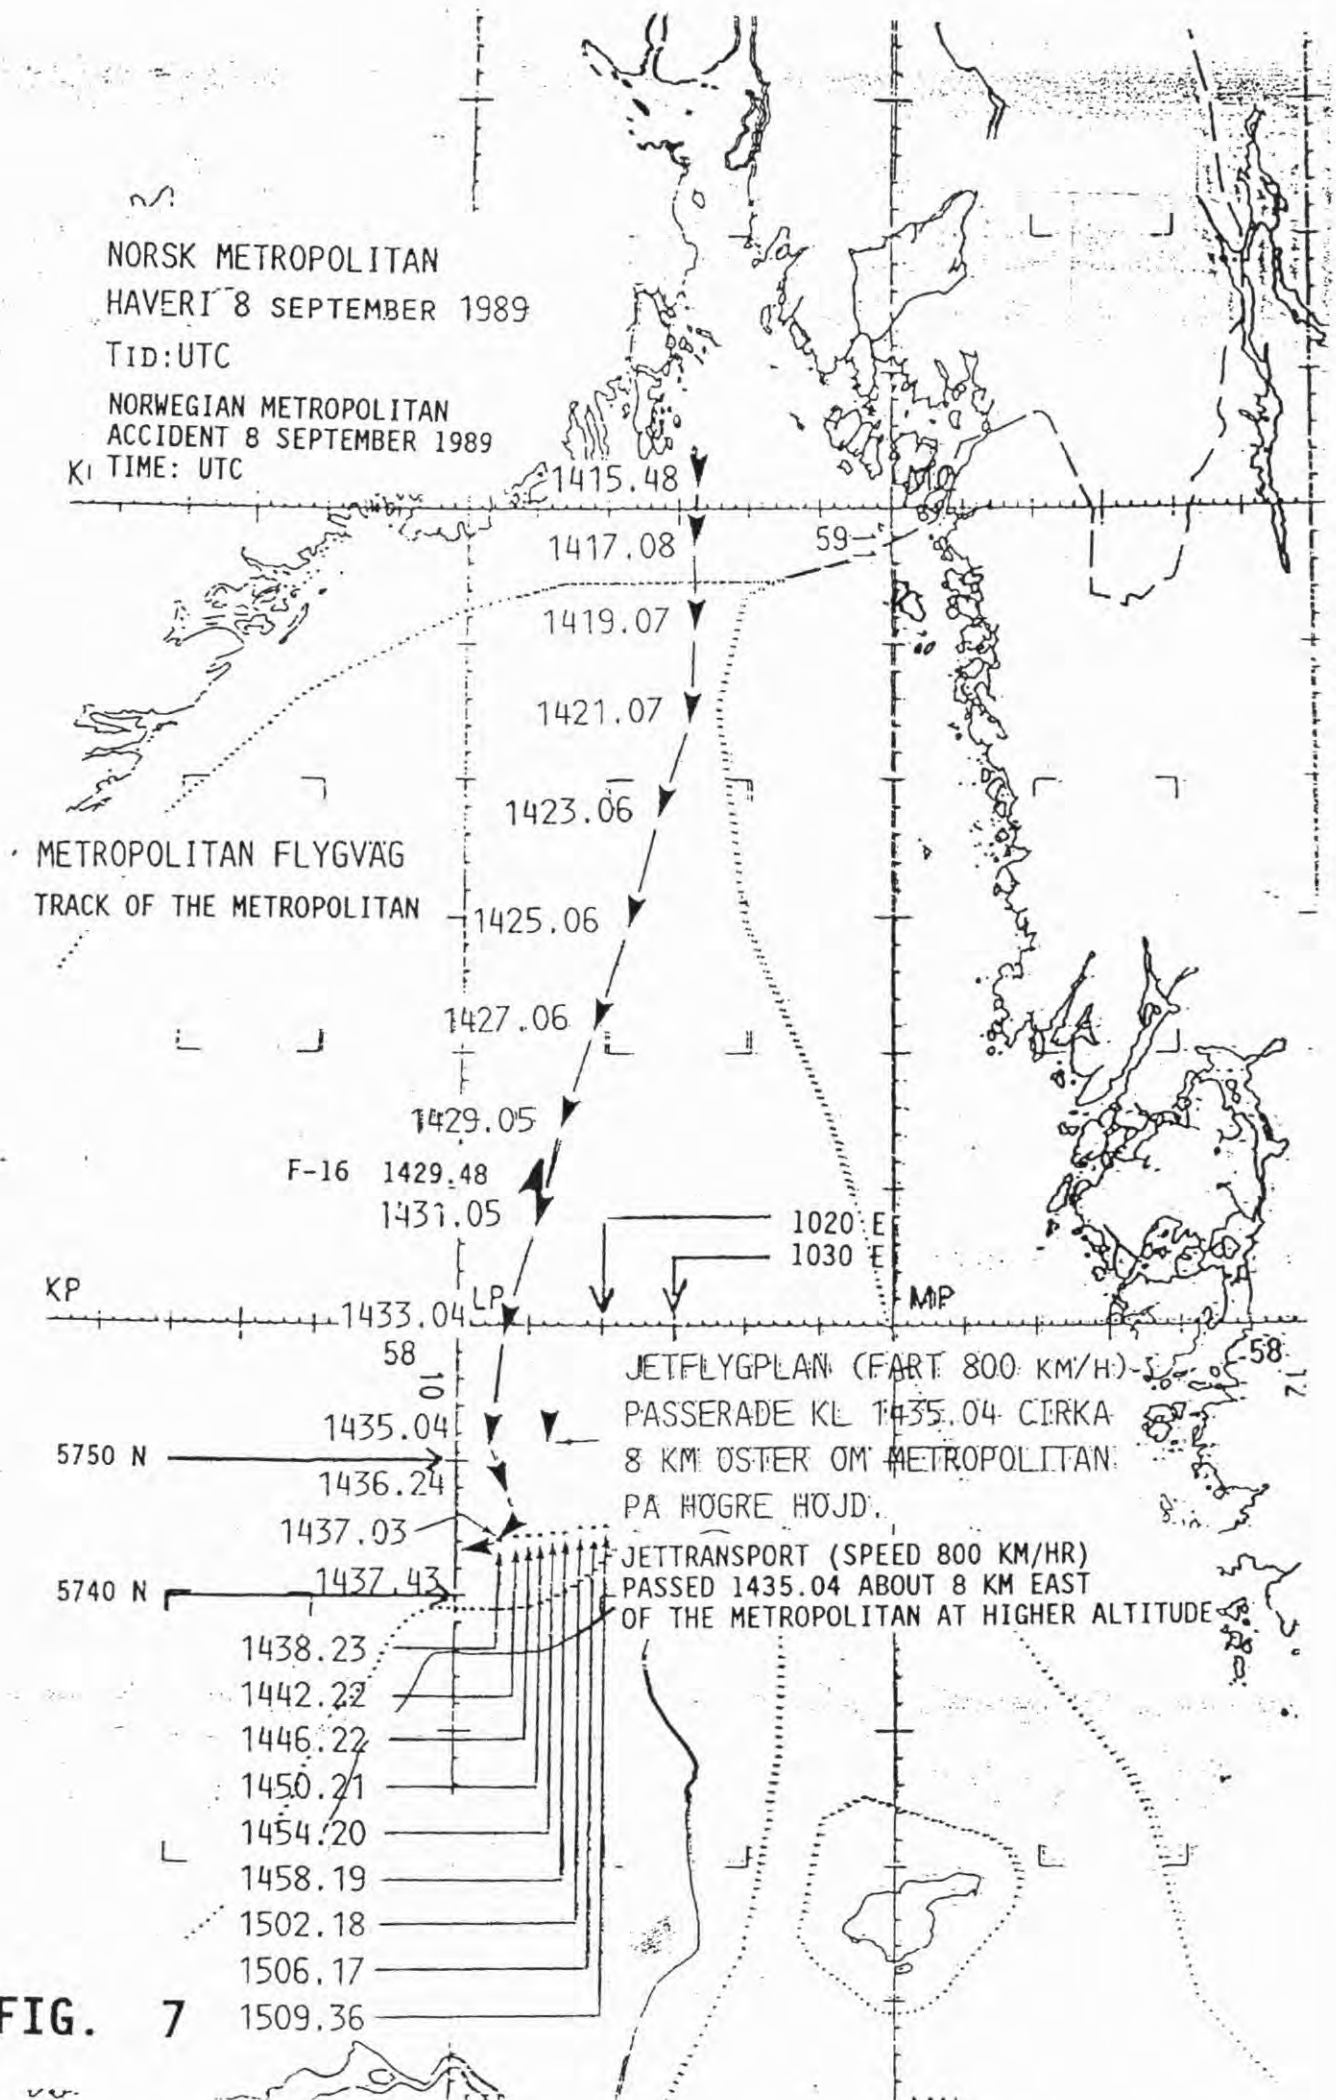
FIG. 7

- 1.17.3.13 Swedish radar recordings after 1638:23 hrs (figure 7)

object must have been small and very light. It must also have excellent radar reflection properties. The object was recorded for 2,473 secs (41 mins and 13 secs) from a minimum height of 5,000 m until it disappeared at a height of 400 m. This corresponds to a minimum sink rate of 1.86 m/s. Since the radar hit of the object could have been blocked by the radar hit of the aircraft, the maximum possible height could have been 21,100 ft (6,431 m). This corresponds to a maximum altitude loss of 6,031 m during the same time span. The maximum possible sink rate was thus 2.4 m/s. Both maximum and minimum values pointed to the fact that the object must have been very light. Owing to the characteristics of the radar signal the experts judged the object to be quite small.

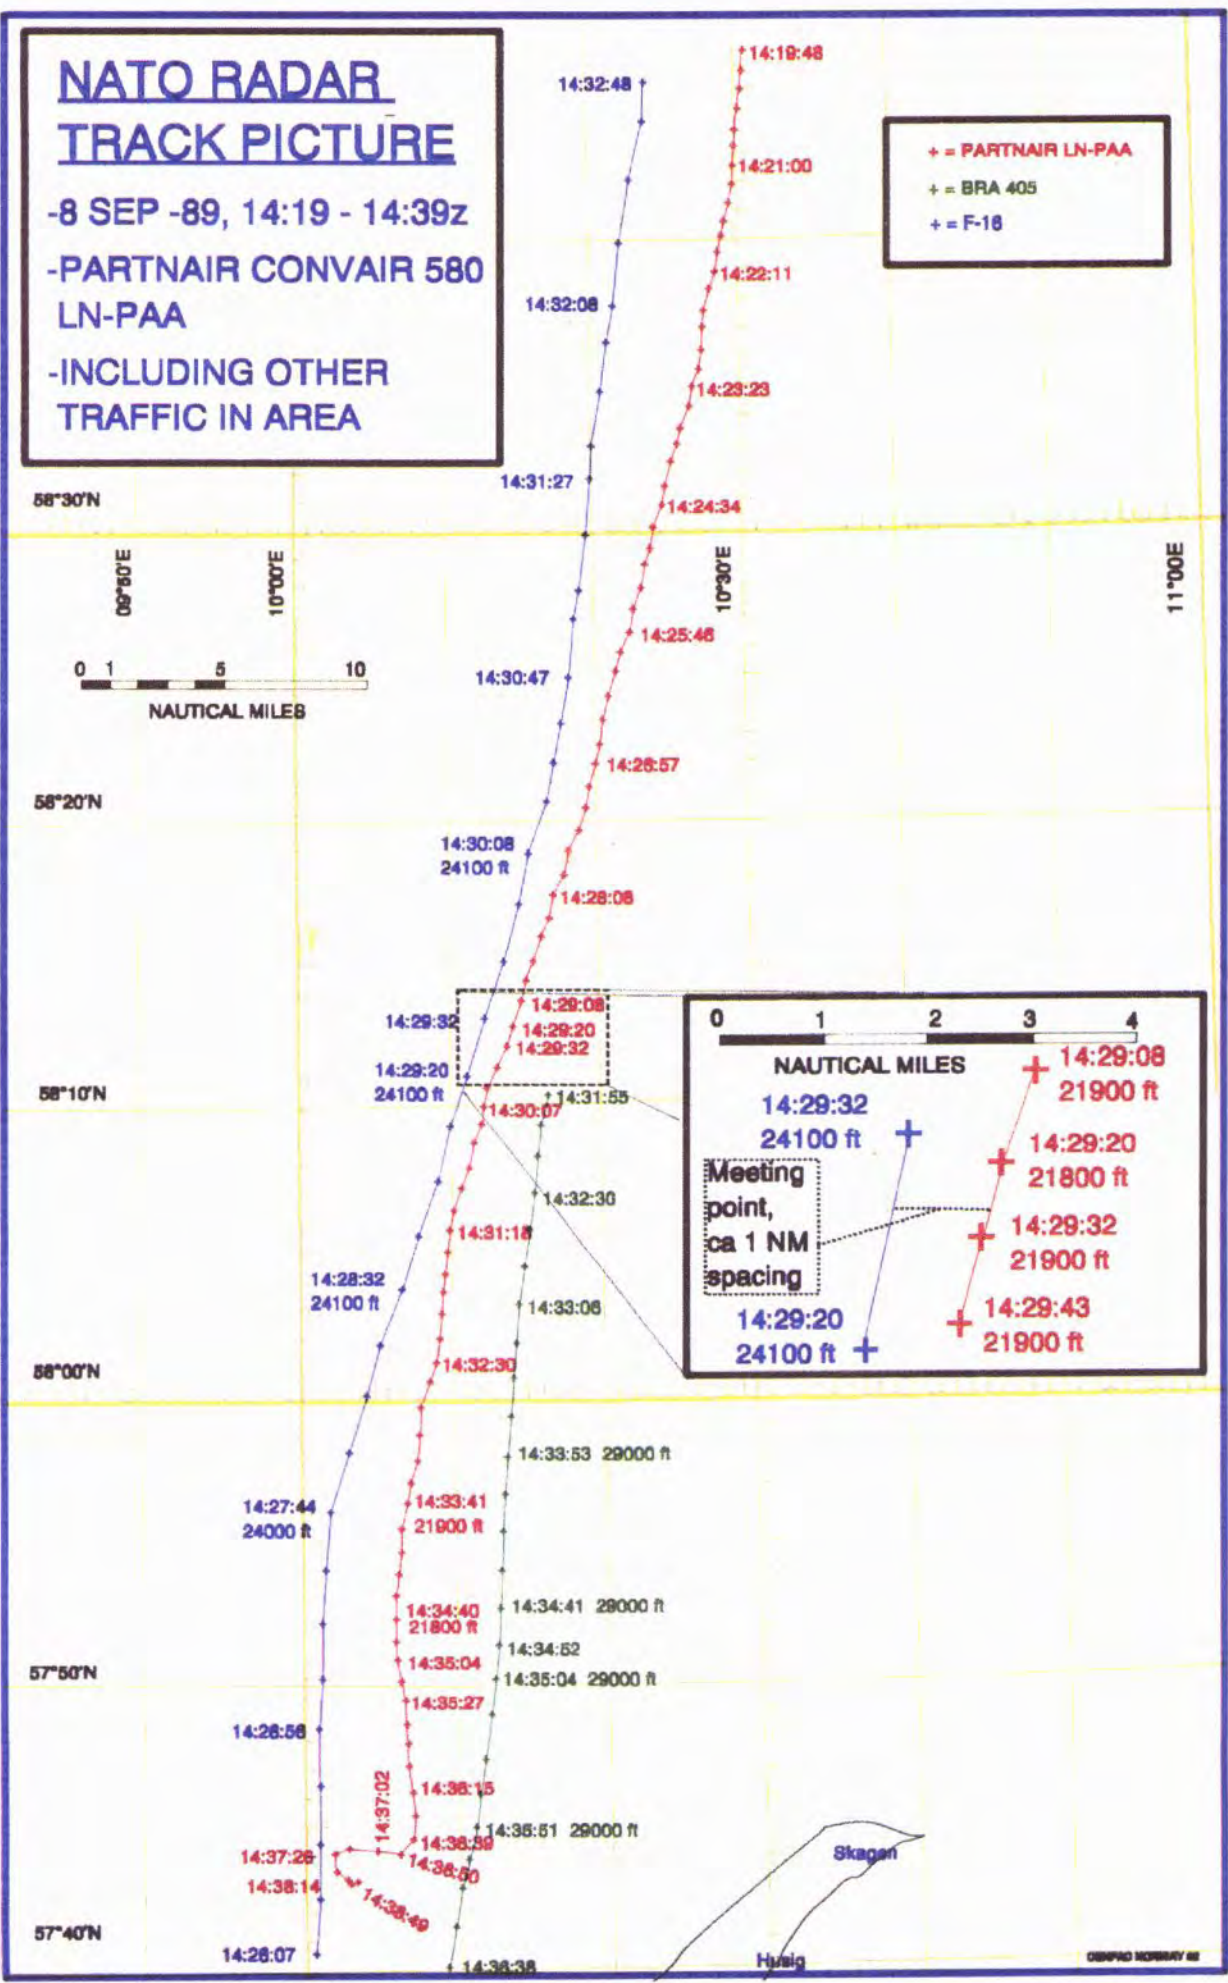
FIG. 8

- 1.17.4.1 In addition to LN-PAA, other air traffic in nearby airspace consisted of a B-737 Braathens SAFE passenger flight (Flight No. BRA 405) en route from Fornebu to Billund and a Norwegian F-16 fighter aircraft en route from Aalborg to Rygge under civilian air traffic control. The two aircraft had established their respective cruising levels when they passed LN-PAA. LN-PAA maintained FL 220, BRA 405 maintained FL 290 and the F-16 maintained FL 240. According to radar information, all the aircraft were identified as friendly, i.e. known traffic (figure 8).

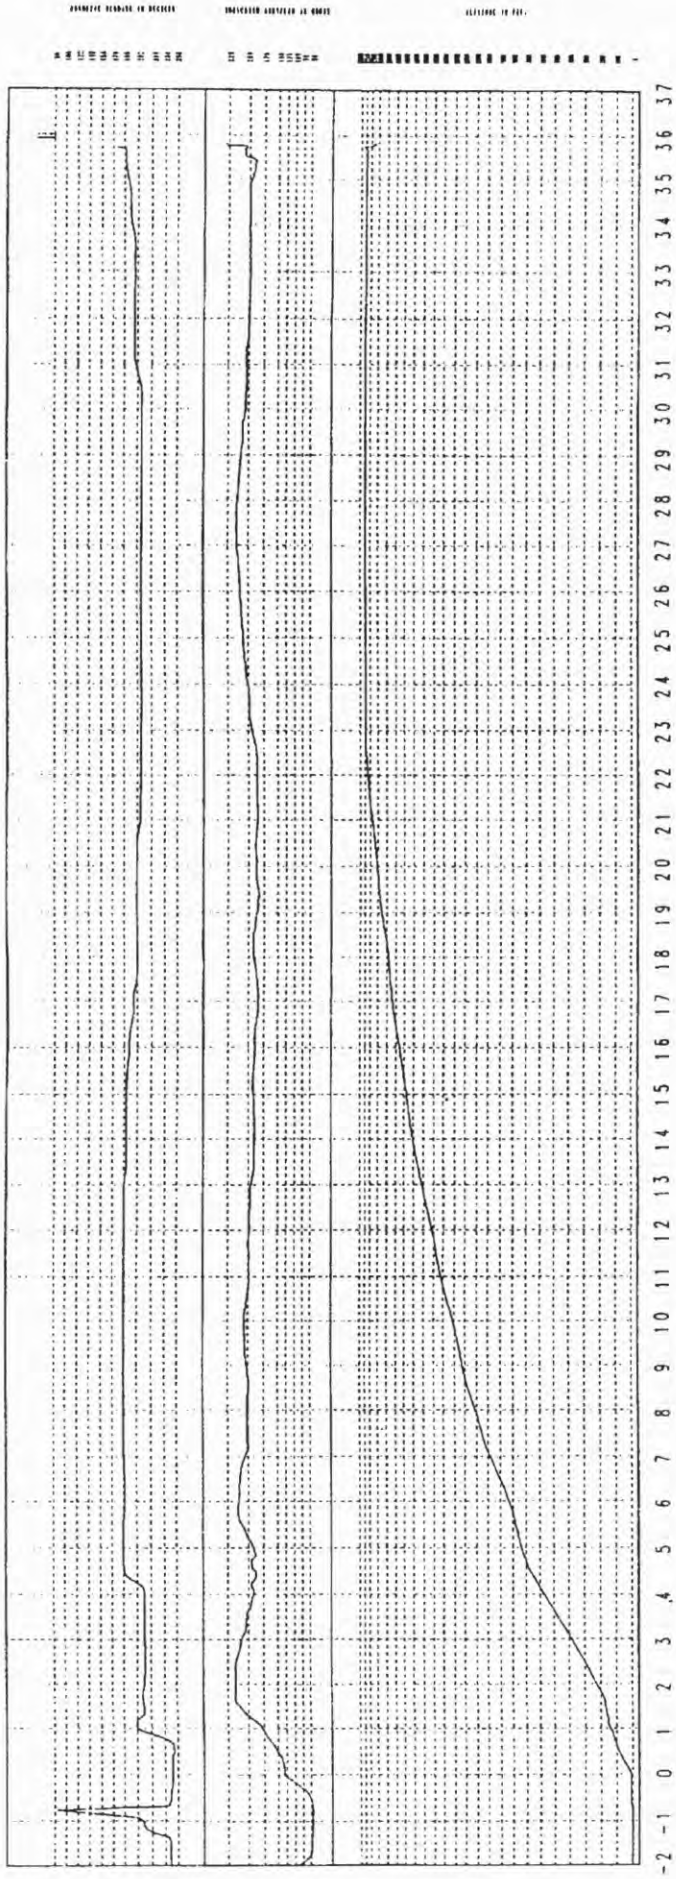
Complete FDR Readout for the accident flight, Convaair 580, LN-PAA.

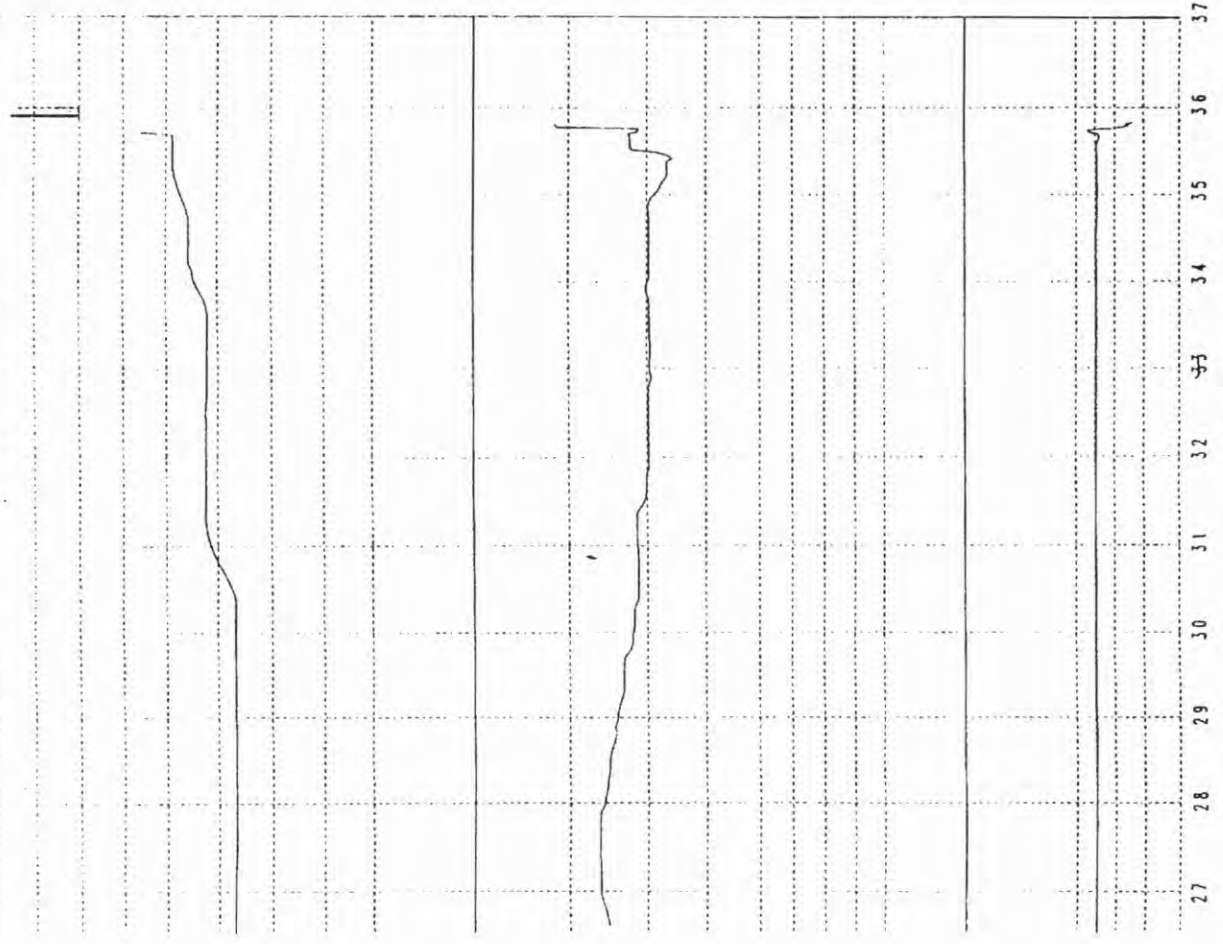
FDR Readout data for the last 9 minutes of the accident flight, Convaair 580, LN-PAA.
