REPORT

JB 2009/03

REPORT ON LEVEL CROSSINGS

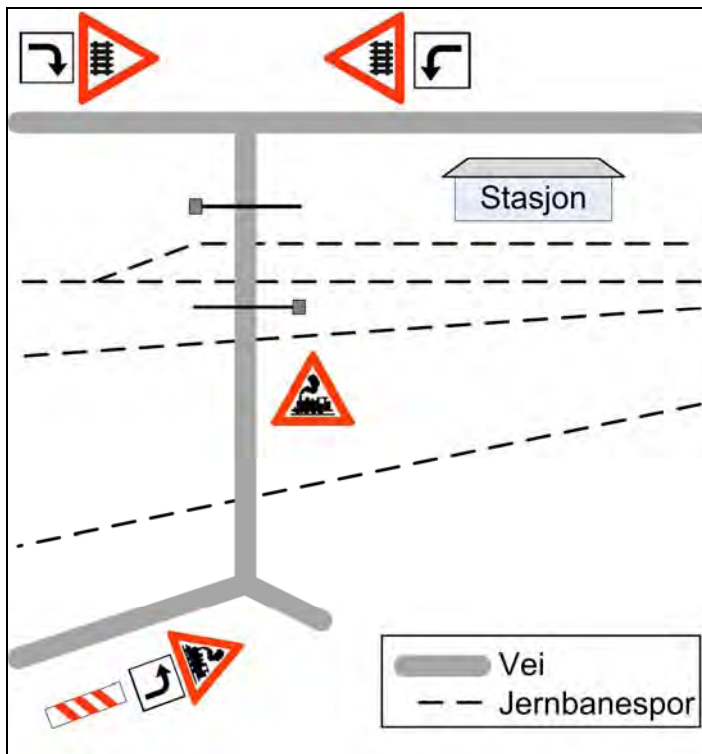
At Ranheim station (Figure 18), four tracks cross the road along a short road section. The two tracks nearest the station are safeguarded by barrier systems. It is often the case that the barriers are open and motorists have the all clear signal while a stationary train is waiting at the station.

If a motorist focuses on the stationary train (Figure 19) while the barriers begin to descend, there is a risk that the motorist will think that it is the stationary train at the station that is about to depart rather than a train approaching from the left. In the worst case, the motorist may reverse in order to clear the track nearest the station (Figure 20) and thus end up on the approaching train's track.

Figure 18: Overview of roads and railway lines at Ranheim.

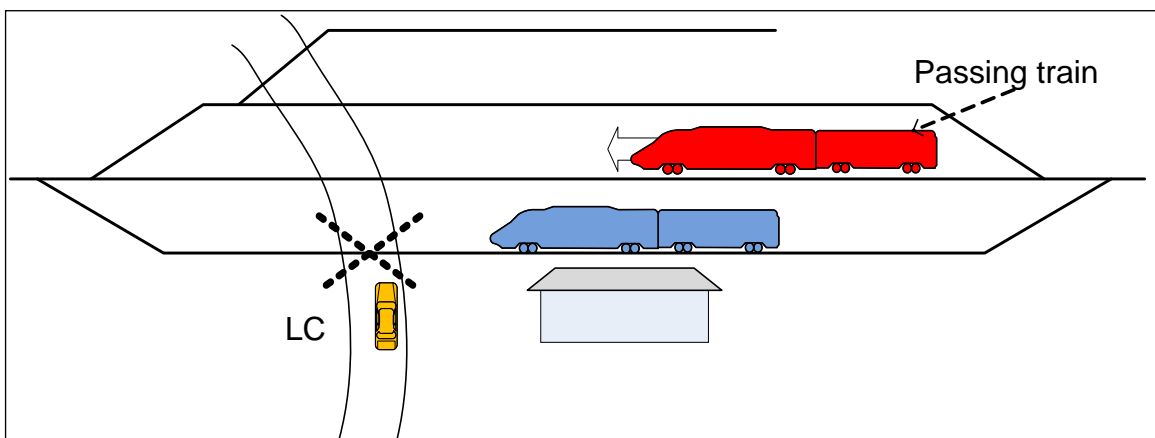
Problems associated with crossing and overtaking exist at level crossings at stations where trains either cross each other's tracks or overtake each other. Pedestrians and motorists frequently tend to focus on the stationary train that is waiting at the station for the approaching train to pass. There is a risk that pedestrians do not respect the barriers because they assume that these have been lowered for the stationary train, and hence take the risk of crossing the level crossing without sufficient attention to the crossing/overtaking train that might be moving at a relatively high speed.

Figure 26: Diagram showing the problems associated with crossing and overtaking (like at Dal station).

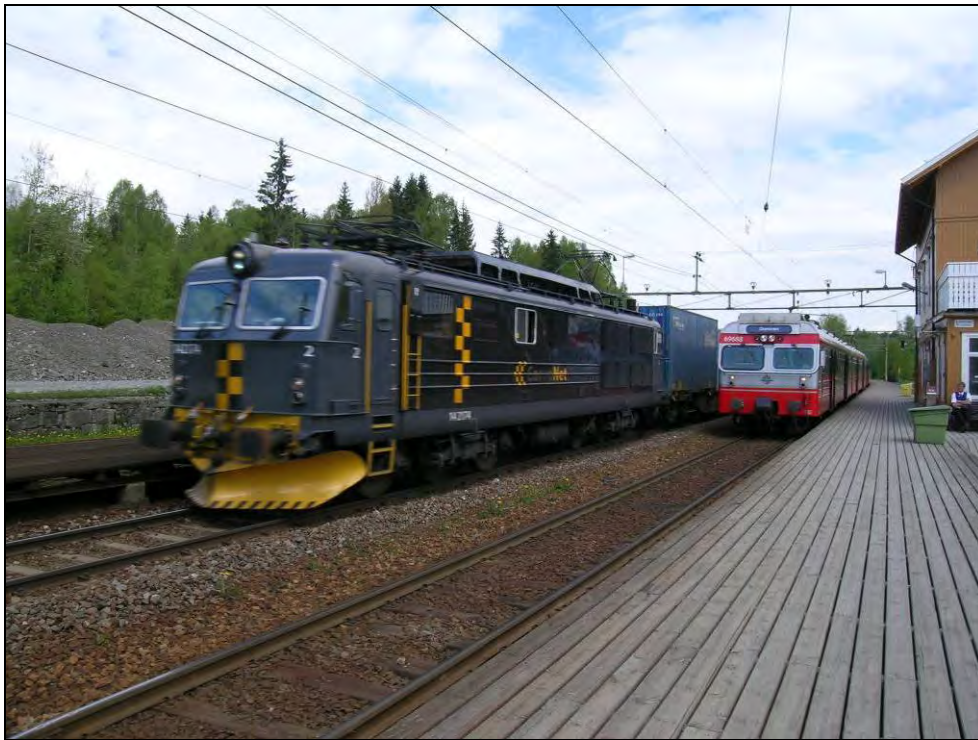
Figure 27: An overtaking freight train at Dal station.

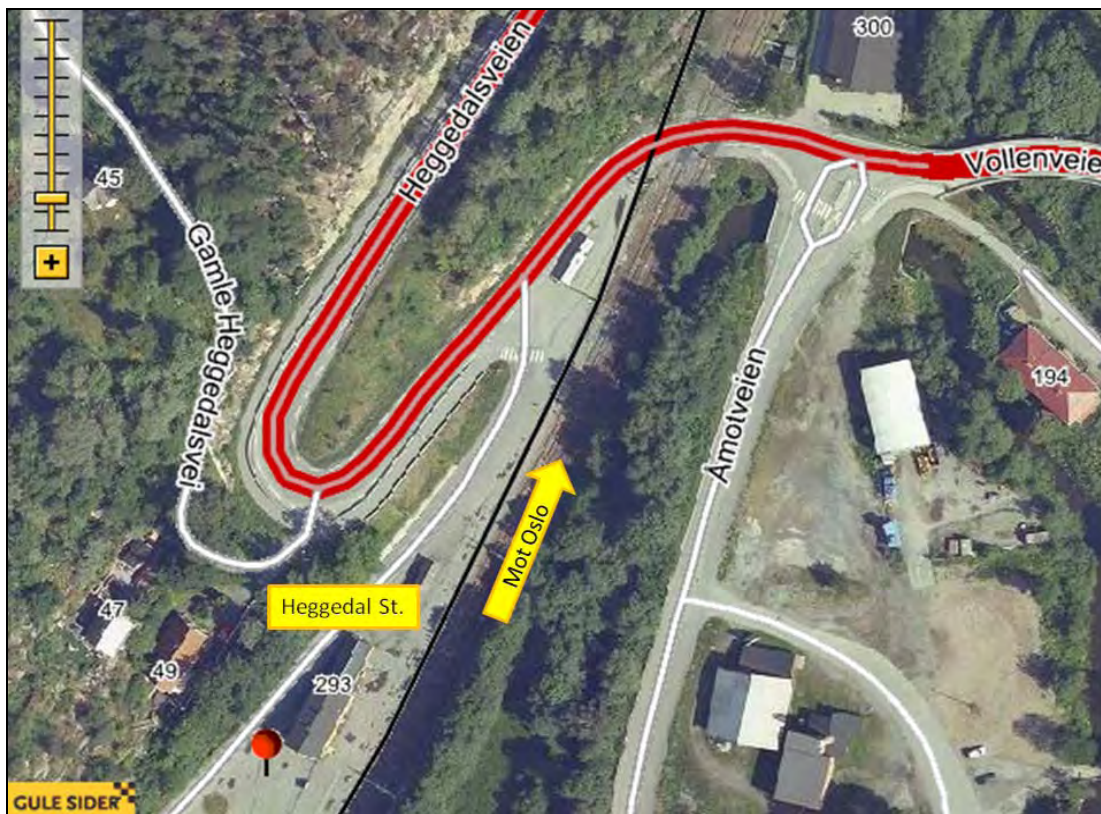
Figure 32: Heggedal LC.

When the train bound for Oslo passes, the barrier is down for approx. 4 min 20 sec. Approx. 1 min 30 sec passes from the barrier begins to descend until the approaching train can be spotted, and, on average, approx. one train per hour passes in each direction.

During the inspection, three persons who were going to catch the train to Oslo were observed bypassing the barriers. When asked directly why they broke the rules, one of them answered as follows: ‘The barriers are always down for approx. two and a half minutes before the train leaves. I often run across the track after the barrier has descended. A train has never approached unexpectedly from the other side. Everyone in the area does this.’ (Woman, approx. 20-25 years old)

A motorist, a learner driver true enough, had to reverse in order to prevent the barrier from hitting the car (on the Heggedalsvei side) The road was recently asphalted and it is therefore unknown whether it is normally marked with a stop line in accordance with the recommendations in the NPRA Manuals.^{9,10} Furthermore, since the barrier is not correctly installed (i.e. perpendicular to the road), an inattentive driver can be caught on the crossing or the car could be hit by the descending barrier.

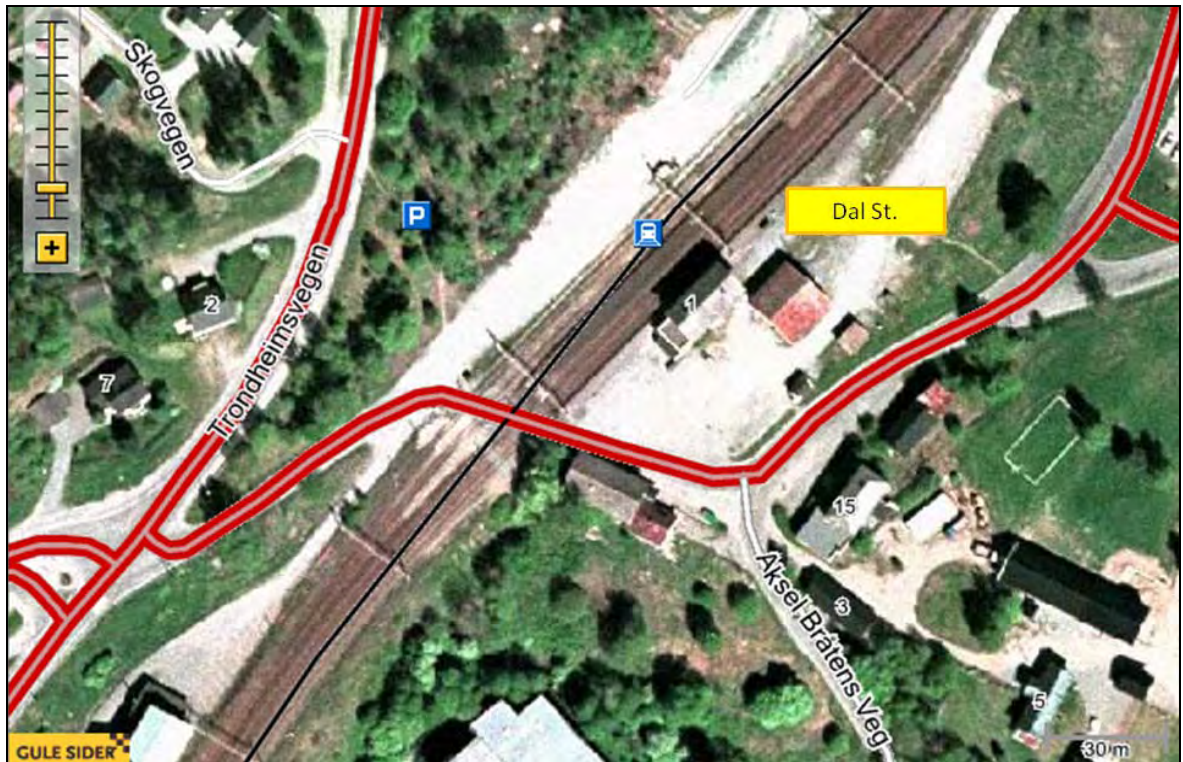
Figure 39: Dal LC.

During the inspection, AIBN observed the crossing of a freight train and a local train that stops and changes direction at Dal station. While the train was crossing, the barriers were down for approximately 7 min and 15 sec. During this time, the local train for Oslo was waiting at the station.

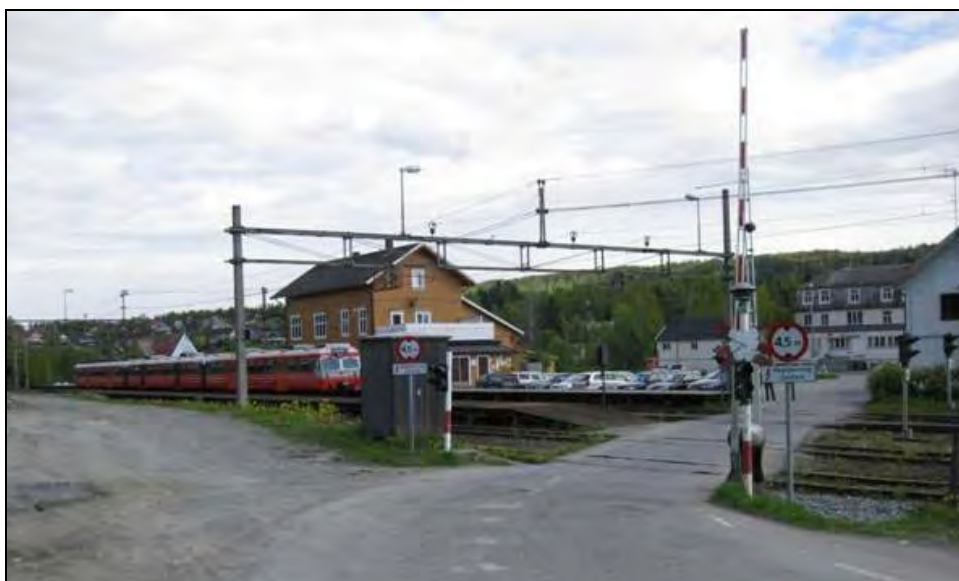
Another problem is that both pedestrians and motorists have a very short sight distance when waiting on the station side of the level crossing to cross to Trondheimsvegen. The photo on the following page (Figure 40) shows how the stationary train, platform and buildings block the sight lines from the barriers at the level crossing.

Figure 41: Dal station, the level crossing and a stationary local train.

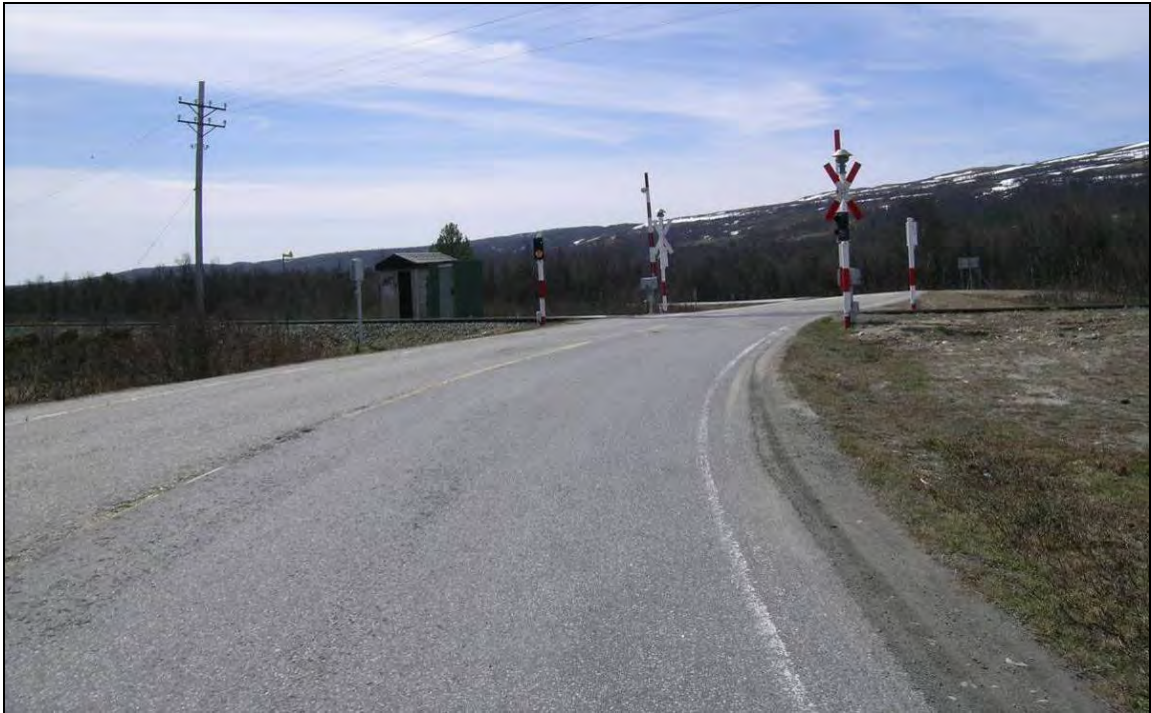
majority of reports concern damage to the barriers or light poles following a collision with a vehicle. In most cases these incidents were classified as 'Motorist - unintentional wrongdoing'. So the problem at these level crossings is not that vehicles cross in front of trains, but rather those motorists lose control of their vehicles and damage the system. In the worst case, vehicles may skid onto the track.

Figure 42: Inspection of Harborg LC on the Røros line.

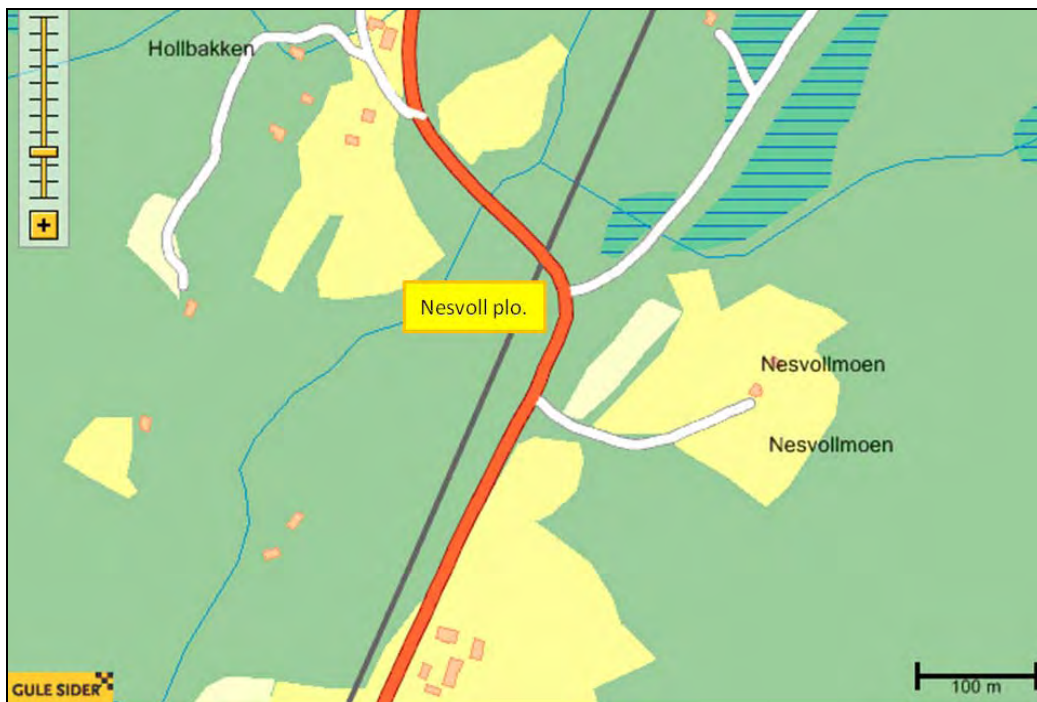
Like Harborg, Nesvoll LC has half barriers, light signals with LED matrices and sound signals. There are also LED matrices on the actual barriers.

Figure 44: Nesvoll LC.

The signs at both level crossings are in accordance with the regulations and in good condition. Incidents almost invariably happen on the same side of the road, i.e. southbound traffic at Harborg and northbound traffic at Nesvoll. In both cases a long stretch of straight road is followed by a sharp turn just before the level crossing (see Figures 43 and 44). Both level crossings have signs showing the recommended speed limit of 40 km per hour.

As a result of a meeting between the Norwegian National Rail Administration, the Norwegian Public Roads Administration and the police, it has been decided that Harborg LC and Nesvoll LC will be equipped with warning signs with flashing yellow lights similar to those at Jømna LC on the Solør line and at Tomsbakken LC on the Vestfold line (see the figures below).

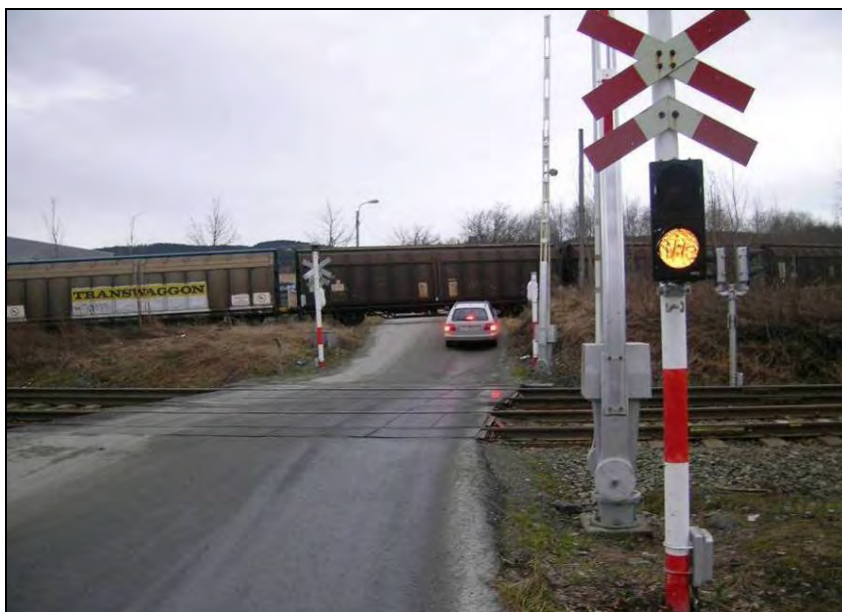
If the road slopes down towards a level crossing, vehicles may have difficulty braking when the road surface is slippery. In the opposite case, when there is a slope leading up to the level crossing, a hazardous situation may arise as a result of the vehicle being unable to start quickly enough to get across the level crossing when the road is slippery. One example of such a level crossing is Ranheim, where the road has quite a steep gradient at the level crossing (Figures 58 and 18). Another example is Gubberud LC, where a collision between a vehicle and a train was also assumed to have been caused by a slippery road surface (Figure 59).

Figure 58: Slope leading up to a level crossing (Ranheim LC).

Pursuant to the rules, barriers must be located on either side of the road. Despite that, there are still examples of level crossings where both barriers are located on the same side of the road, e.g. Ranheim (Figure 58), Os (Figure 61) and Moss South (Figure 62). In some cases, this has been done to take account of other infrastructure, such as sewage pipes etc. The argument against having both barriers on the same side is that vehicles that are trapped between the barriers have a smaller chance of escaping short of smashing through the barrier.

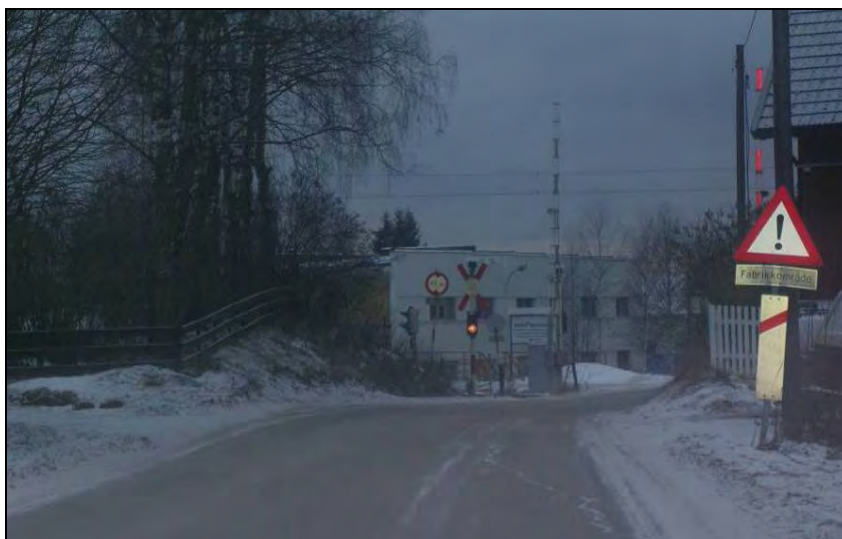
Figure 59: Slope leading down to a level crossing (Gubberud LC).

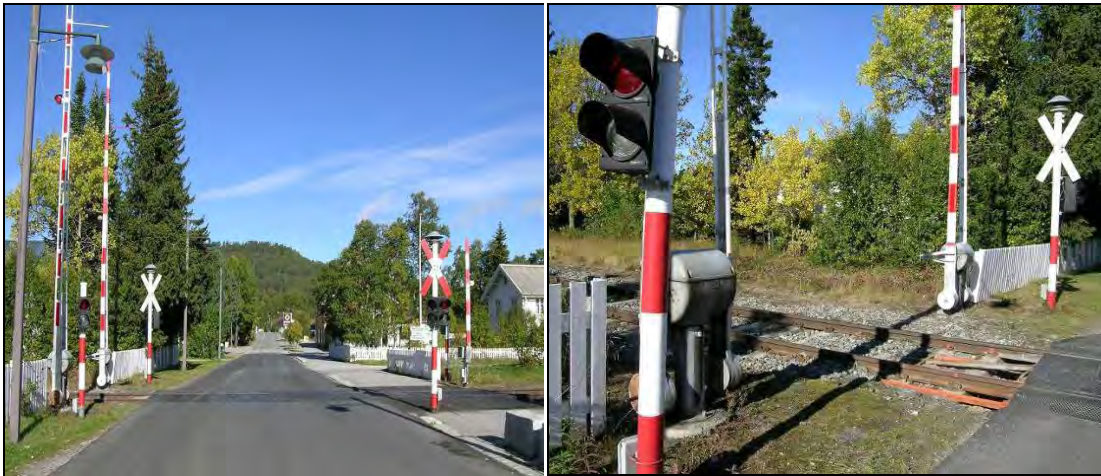
Figure 61: Barriers on the same side of the level crossing (Os LC).

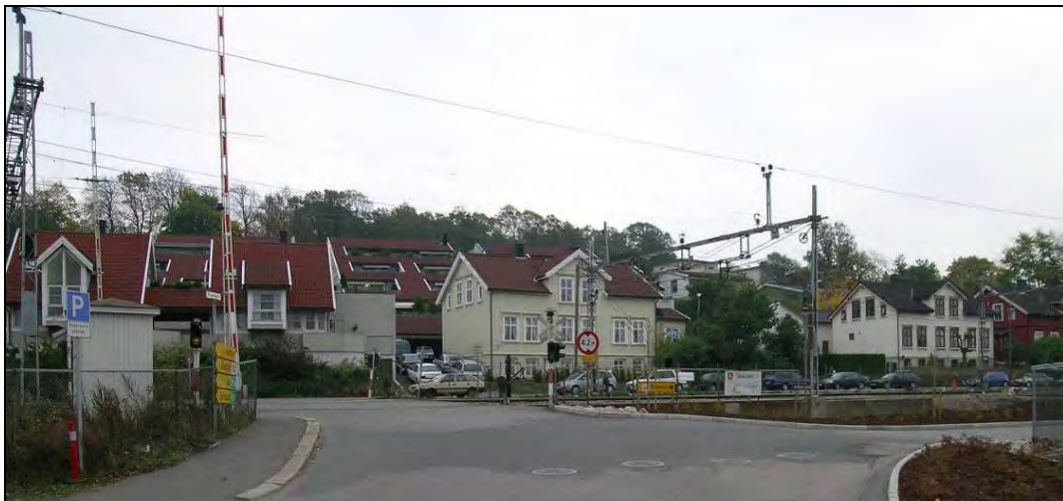
Figure 62: Barriers on the same side of the level crossing (Moss South LC).

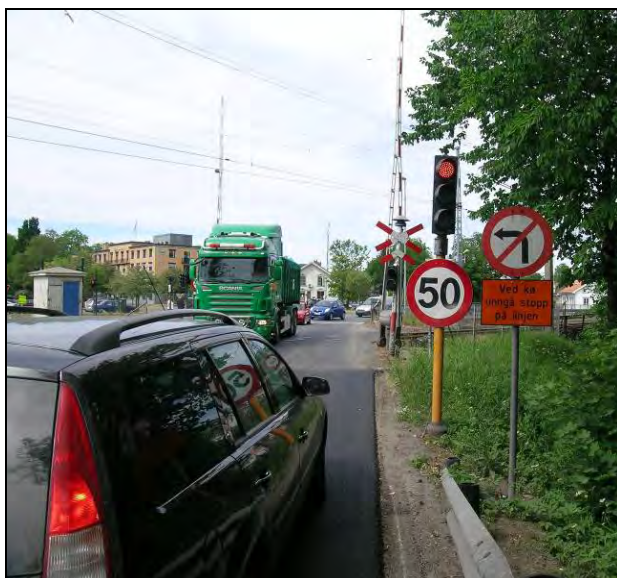
Railway regulations and road traffic regulations do not correspond completely in terms of what they permit. For example, pedestrians can cross the road when the traffic lights are red as long as they do not obstruct other traffic. In the context of railways, it is illegal to cross a level crossing when the lights are red. Motorists are primarily familiar with road traffic rules and it is therefore important that these do not deviate from the railway rules. There are several examples of motorists not stopping at red lights before crossing a level crossing given that the barrier has risen far enough to allow them to pass (see Figure 34). It is particularly important that signals be used together in a uniform manner at level crossings with both railway and road traffic signals. The majority of motorists have a better understanding of road traffic signals than they have of railway signals, and it is likely that they will pay more attention to the former. If traffic lights or other markings provide ambiguous signals (e.g. the yellow flashing lights at Porsgrunn or the lack of a stop line at Heggedal), this may cause drivers to act incorrectly. In other words, it is very important that road traffic authorities and railway authorities collaborate on signage in order to ensure that there is no confusion (examples of combined signage/signalling are shown in Figures 63 and 64 below).

Figure 63: Road traffic and railway signs (Porsgrunn).

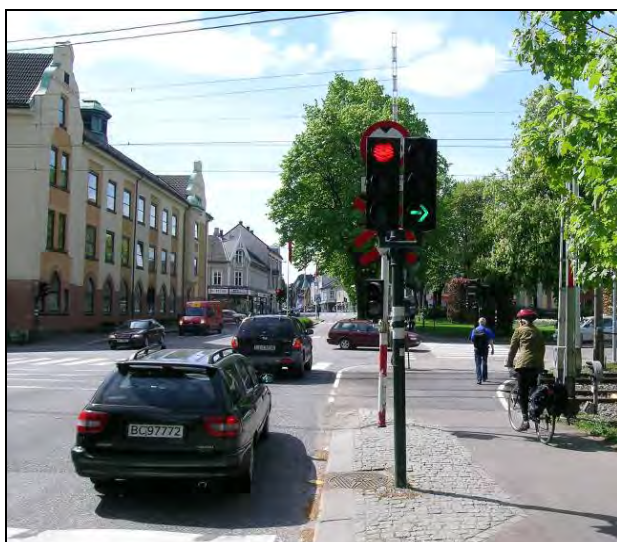
Figure 64: Traffic light in front of a railway sign (Tønsberg).
