SL REP.: 11/2005

**REPORT ON THE AIR ACCIDENT ON 30 NOVEMBER 2001 AT SKIEN AIRPORT  
GEITERYGGEN NORWAY, INVOLVING BRITISH AEROSPACE JETSTREAM 31, SE-  
LGA, OPERATED BY EUROPEAN EXECUTIVE EXPRESS AB**

SUBMITTED APRIL 2005

ACCIDENT INVESTIGATION BOARD - NORWAY  
PO BOX 213  
2001 LILLESTRØM  
NORWAY

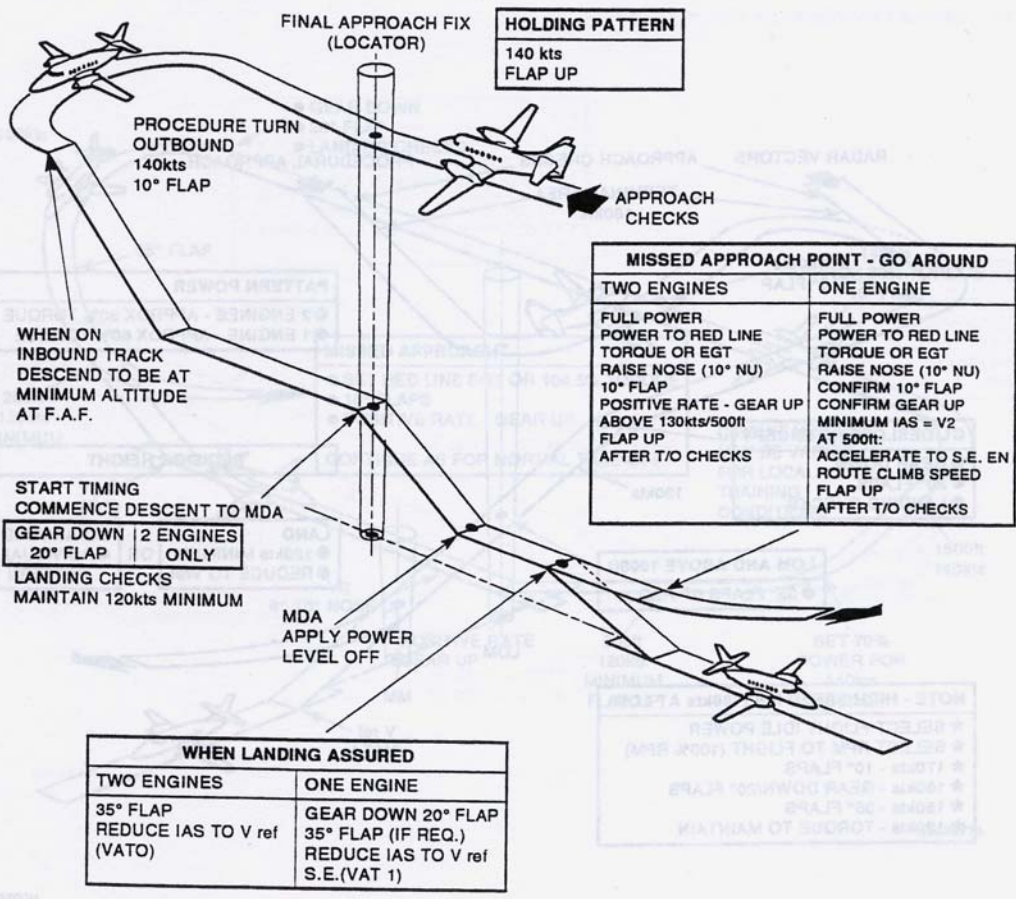
NON PRECISION APPROACH  
 FIG. 4

**NOTE:**  
 IF CARRYING OUT SINGLE ENGINED  
 CLOUD BREAK PROCEDURE, CIRCLE TO LAND  
 WITH 10° FLAP, SELECT GEAR DOWN AND 20°  
 FLAP WHEN TURNING ONTO BASE LEG
