# REPORT

## Marine 2019/02

## MAPPING OF RECREATIONAL CRAFT ACCIDENTS PART A MAPPING OF ACCIDENTS 2018

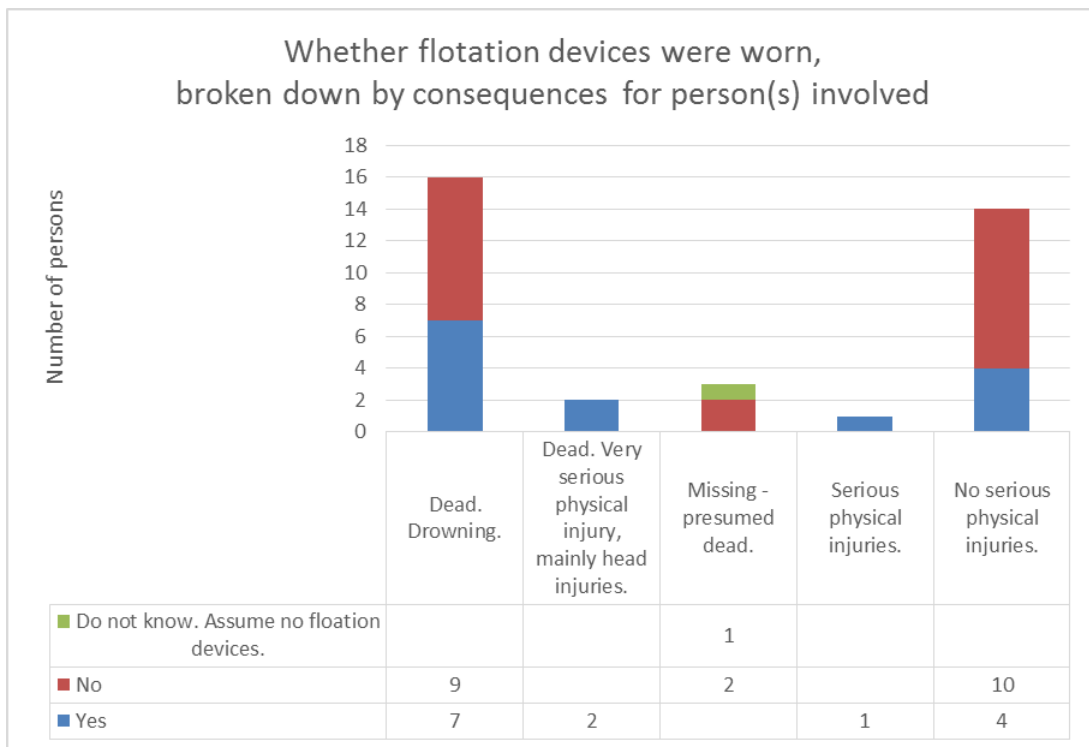
Figure 32: Number of persons and whether or not they were wearing flotation devices, broken down by consequences.

Nine persons (out of the 19 who drowned or are assumed to have drowned) were not wearing any flotation devices; see Figure 32 and Figure 33. Three of the persons who were not wearing any flotation devices died after falling into the water between the craft and a jetty. It is probable that none of the three missing persons were wearing flotation devices.

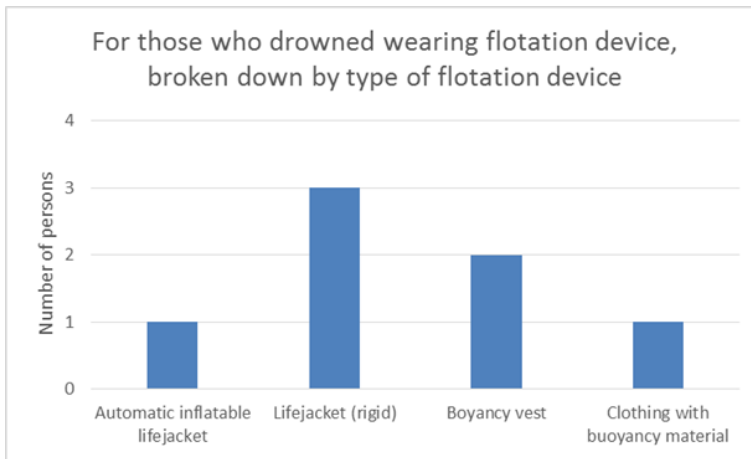
Figure 37: Number of persons who were wearing flotation devices, broken down by type of device. The figures are limited to people who were wearing flotation devices and who drowned or are assumed to have drowned.

Seven of those who drowned (of the 19 who drowned or are assumed to have drowned) were wearing flotation devices. See Figure 37 for a description of the types of flotation devices. Table 7 describes the use of flotation devices for the people who drowned and why they did not keep the airways clear. The persons who drowned after falling into the water from a canoe, a kayak and an SUP board are also included in this assessment. None of them were wearing a dry suit. In summary, those who wore flotation devices either did not wear them correctly or they did not keep the airways clear when the person lost consciousness or in other ways lost the ability to take care of themselves.

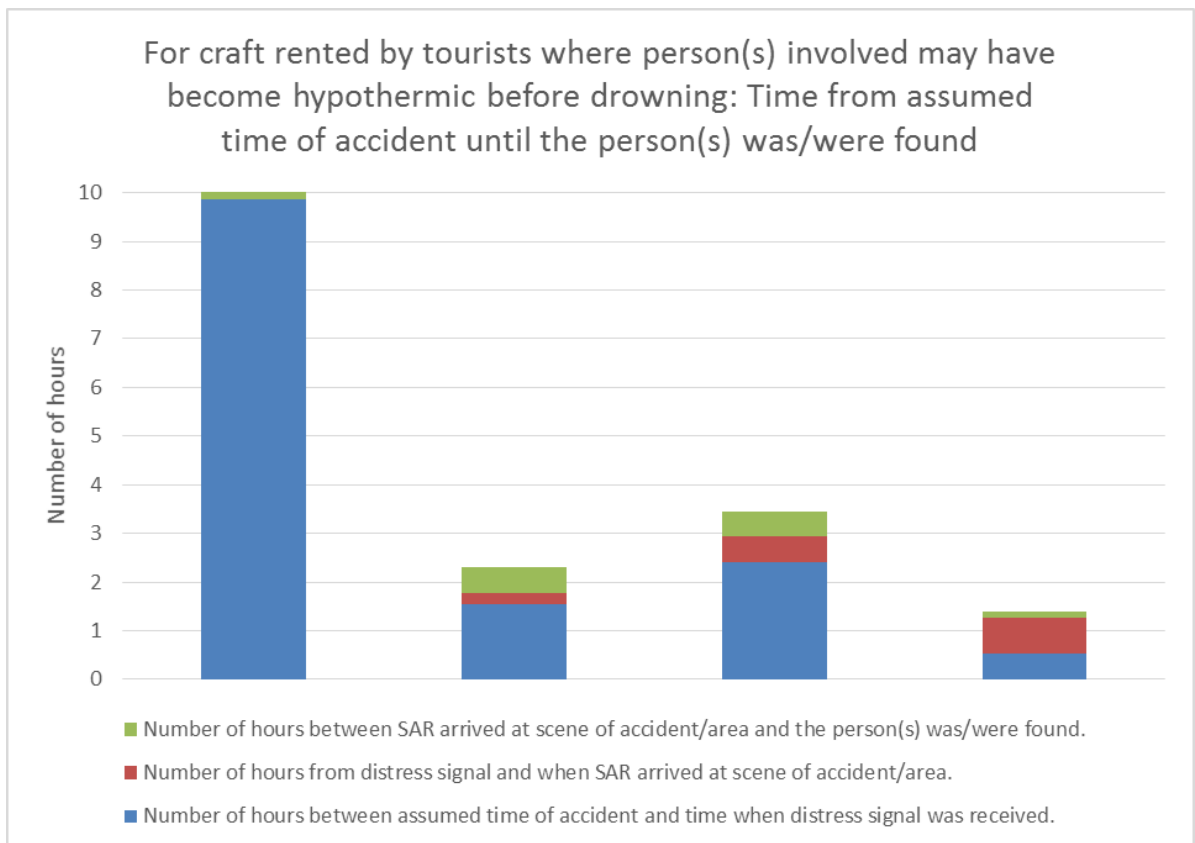
Figure 40: Boat rental for tourists. All the victims may have become hypothermic before drowning. Each bar represents one accident and specifies the time that elapsed from the assumed time of the accident until the persons involved were found. The maximum time in the figure is 10 hours. In one of the accidents, the person was found lifeless before the police were notified of the situation.

In three out of the four accidents, more than an hour and a half elapsed before anyone else realised that the persons were in trouble; see Figure 40. The persons involved in the fourth accident were unable to explain their location, which delayed the rescue operation. Some of the persons had mobile phones, but most were unable to use them to call for help. The questions has been raised whether one reason it took so long to notify anyone of the emergency could have been a combination of how instructions from the rental firm were communicated and the foreign nationals' unfamiliarity with the way search and rescue operations are organised in Norway.

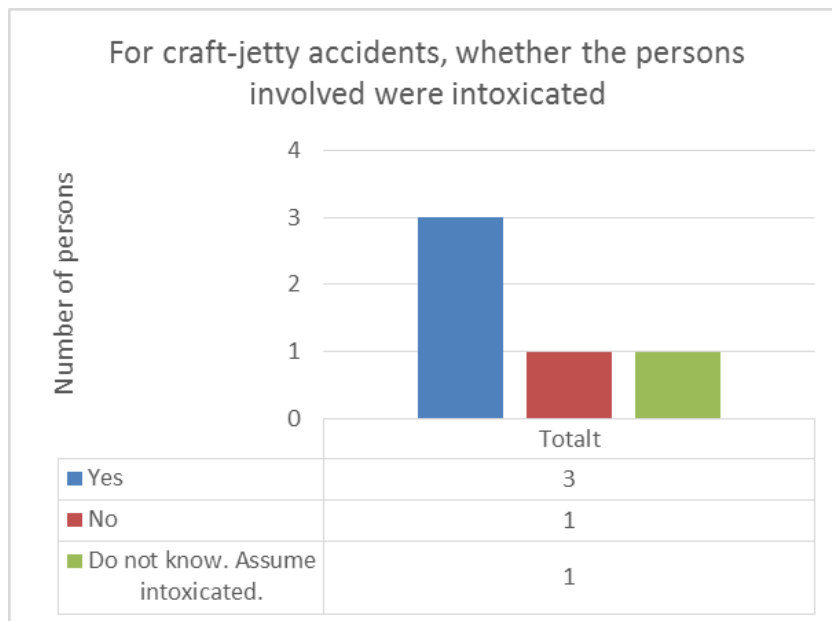
Figure 41: Accidents that occurred while the craft was moored. The figure shows whether the persons were intoxicated or not.

Three out of the total of five persons involved in these accidents were intoxicated. These three persons were severely intoxicated with an average BAC of 0.23%; see Figure 41 and Figure 42. Another person was probably intoxicated, but no blood sample was collected. Severe intoxication impaired the persons’ physical and cognitive skills significantly, contributed to the accident and limited their ability to take care of themselves after the accident had occurred.

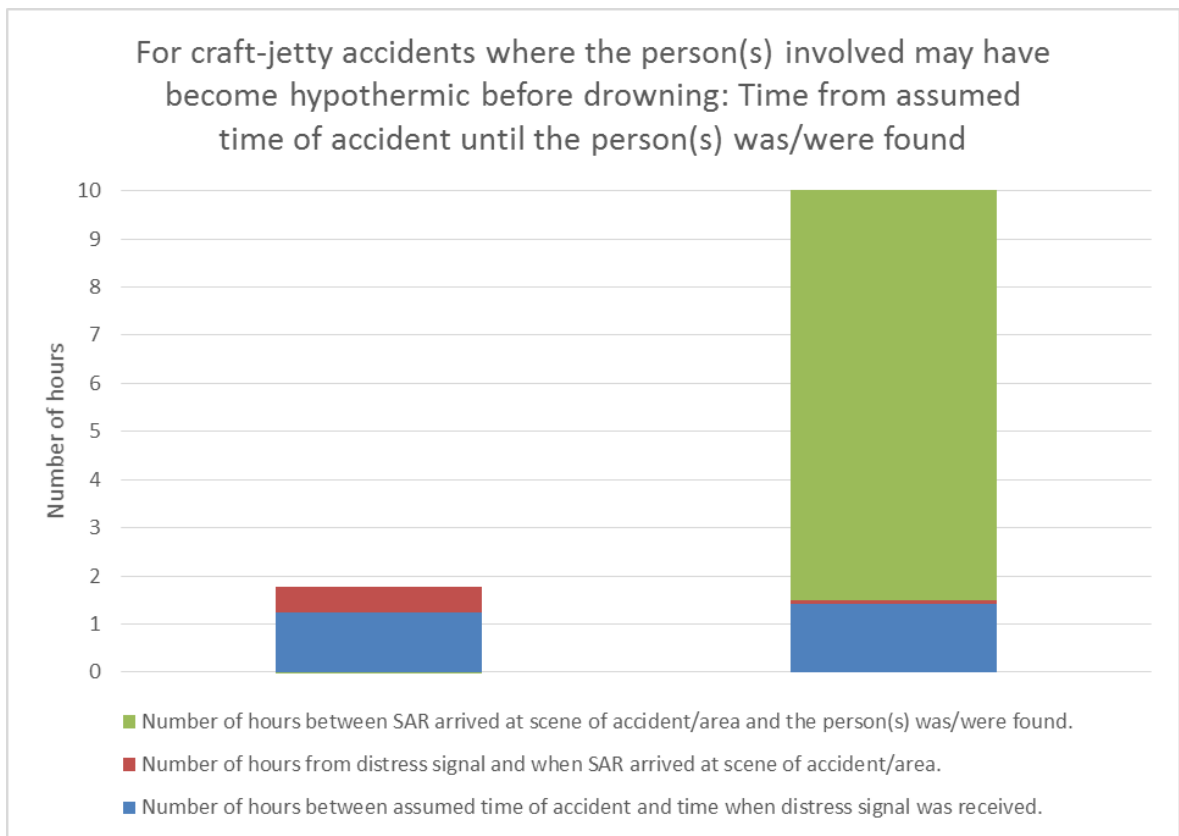
*Figure 43: Craft-jetty accidents where the persons involved may have become hypothermic. Time from the assumed time of the accident until the persons were found. The maximum time in the figure is 10 hours. In one case, the person was found dead three days later.*

Provided that they retained buoyancy and clear airways after falling into the water, two person may have developed hypothermia before they drowned; see Figure 43. See Appendix C for details about external conditions.
