Marine 2019/02

MAPPING OF RECREATIONAL CRAFT ACCIDENTS

MAIN REPORT

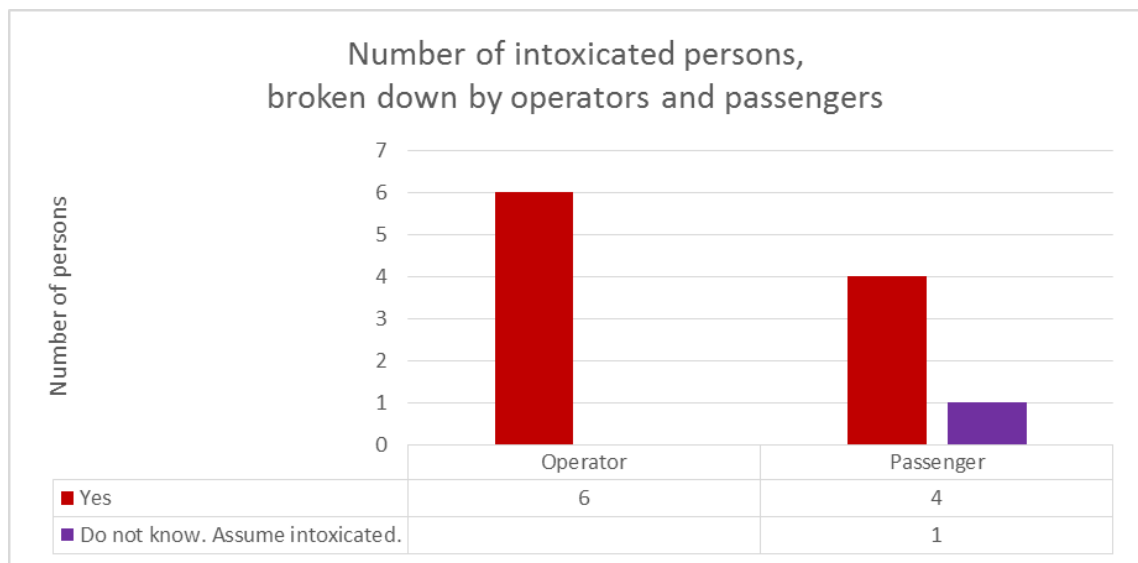
Figure 27: Number of intoxicated persons broken down by whether they were operators or passengers. The figure does not include accidents involving moored craft.

The operators who were intoxicated (in total six persons) had an average BAC of 0.14% (median 0.15%); see Figure 27 and Figure 28. The intoxicated passengers had an average BAC of 0.12% (median 0.12%). The blood alcohol concentrations are for the assumed time of the accident.⁹ These people were all under 50 years of age; see Figure 30.

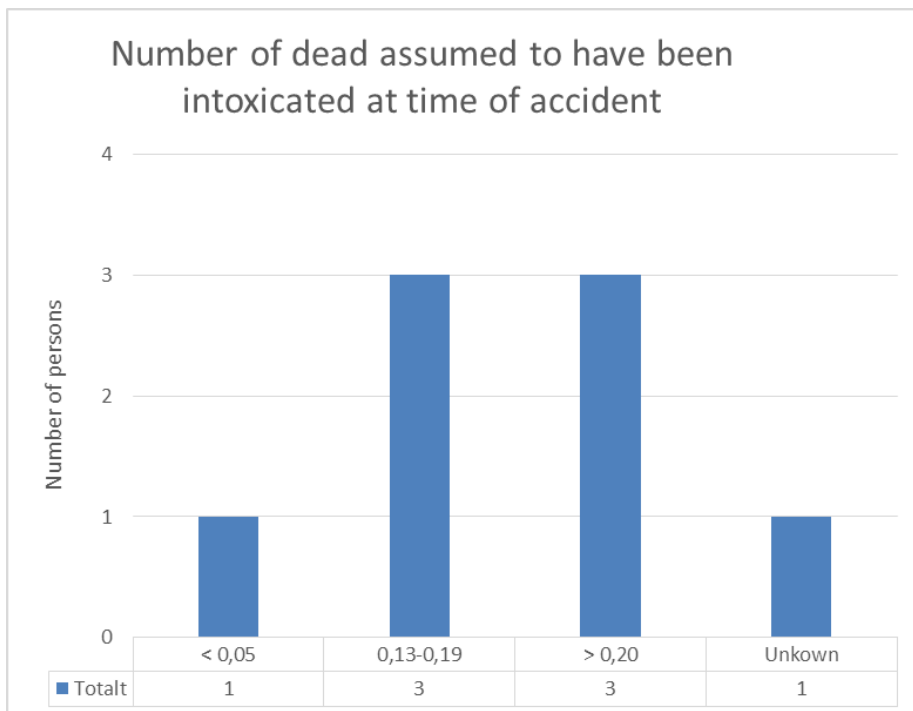
Figure 30: Number of people who died in accidents while intoxicated, broken down by BAC.

Those who died in accidents while intoxicated had an average BAC of 0.17% (median 0.15%) at the assumed time of the accident; see Figure 30. Six of the dead (out of a total of eight) had a BAC of more than 0.13%. Those who fell into the water between a craft and a jetty in particular raise the average BAC. These three persons were severely intoxicated with an average BAC of 0.23%.

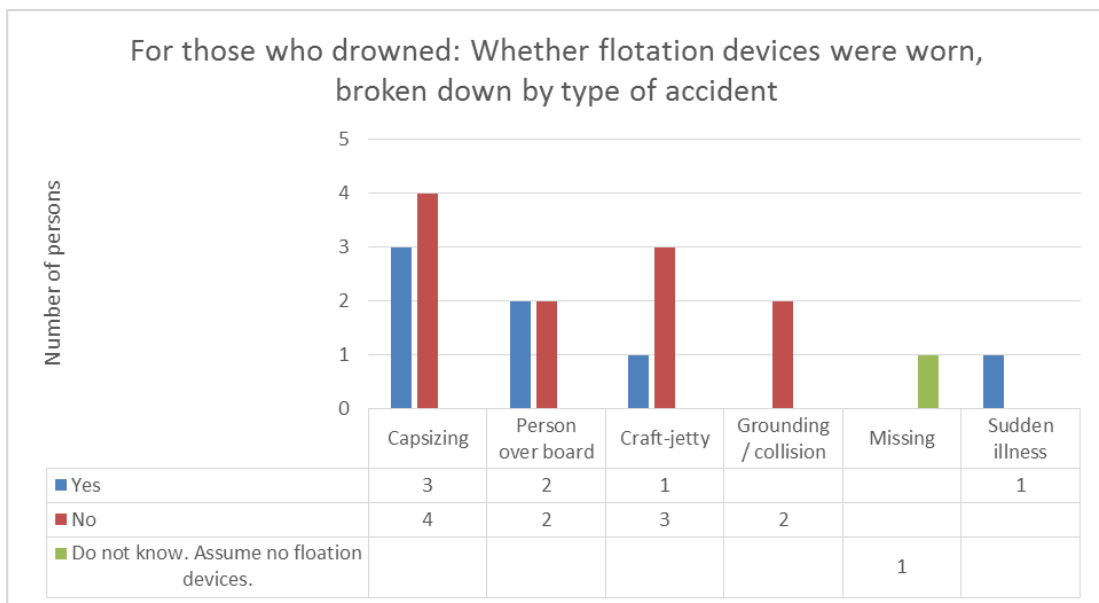
Figure 33: Number of persons and whether or not they were wearing flotation devices. The figures are broken down by type of accident and limited to the persons who drowned or are assumed to have drowned.

Nine persons (out of the 19 who drowned or are assumed to have drowned) were not wearing any flotation devices; see Figure 32 and Figure 33. Three of the persons who were not wearing any flotation devices died after falling into the water between the craft and a jetty. It is probable that none of the three missing persons were wearing flotation devices.

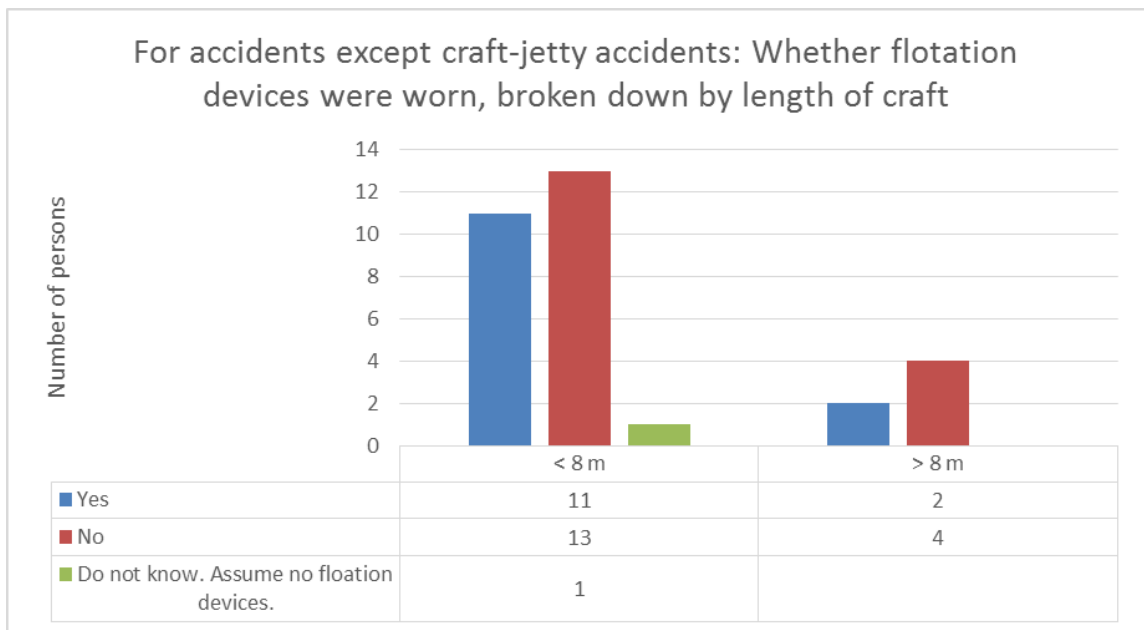
Figure 34: Whether flotation devices were worn, broken down by length of craft. The figures include all accident in which the craft was under way. Accidents where people fall between the craft and a jetty are not included.

The Act of 1 January 1999 relating to recreational and small craft stipulates the requirement that all persons on board recreational craft of less than eight metres in length must wear suitable flotation devices when the craft is under way and the person is on open deck. Fewer than half of the people on board craft of less than eight metres that were under way were wearing flotation devices; see Figure 34 and Figure 35.

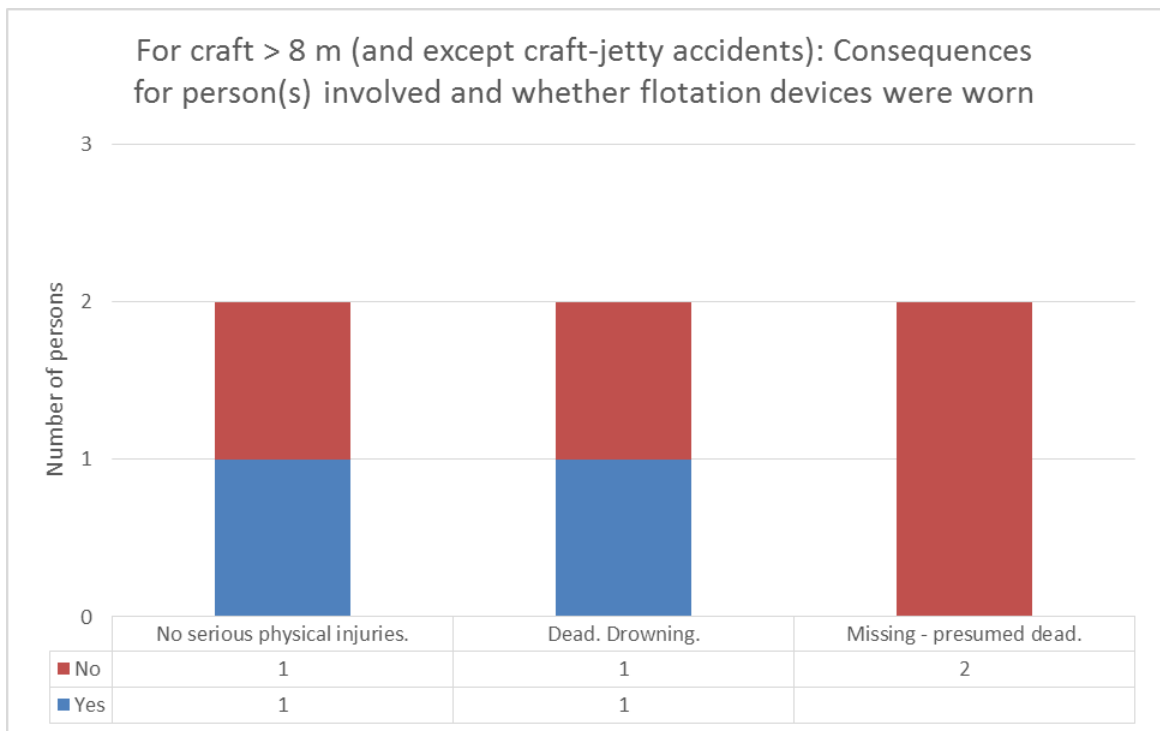
Figure 36: Craft with a maximum length of > 8 m. The figures include all accident in which the craft was under way. The AIBN assumes that the missing persons drowned. Accidents where people fall between the craft and a jetty are not included.

Figure 36 shows corresponding figures for craft longer than eight metres. The figure only includes accidents where the craft is deemed to have been under way. The person were on open deck in all the cases in question. By comparison, a questionnaire shows that 65% state that they always wear flotation devices, 22% usually do, while 10% rarely or never wear flotation devices. The questionnaire did not distinguish between craft shorter and longer than eight metres (KNBF, 2018).

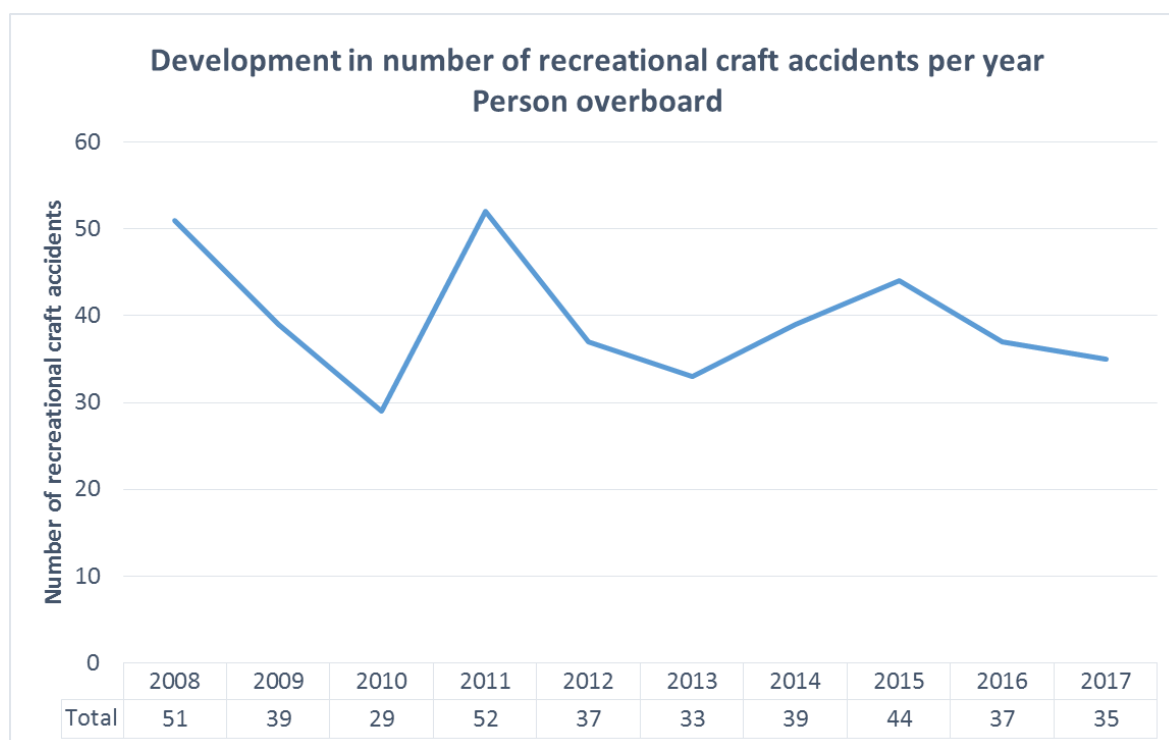
An average of 40 recreational craft accidents involving person overboard incidents were reported each year. This represents 3% of the total number of recreational craft accidents in Norway per year. The development in the number of person overboard incidents shows a slightly decreasing trend; see Figure 13.

Figure 13: Development in the number of recreational craft accidents – person overboard

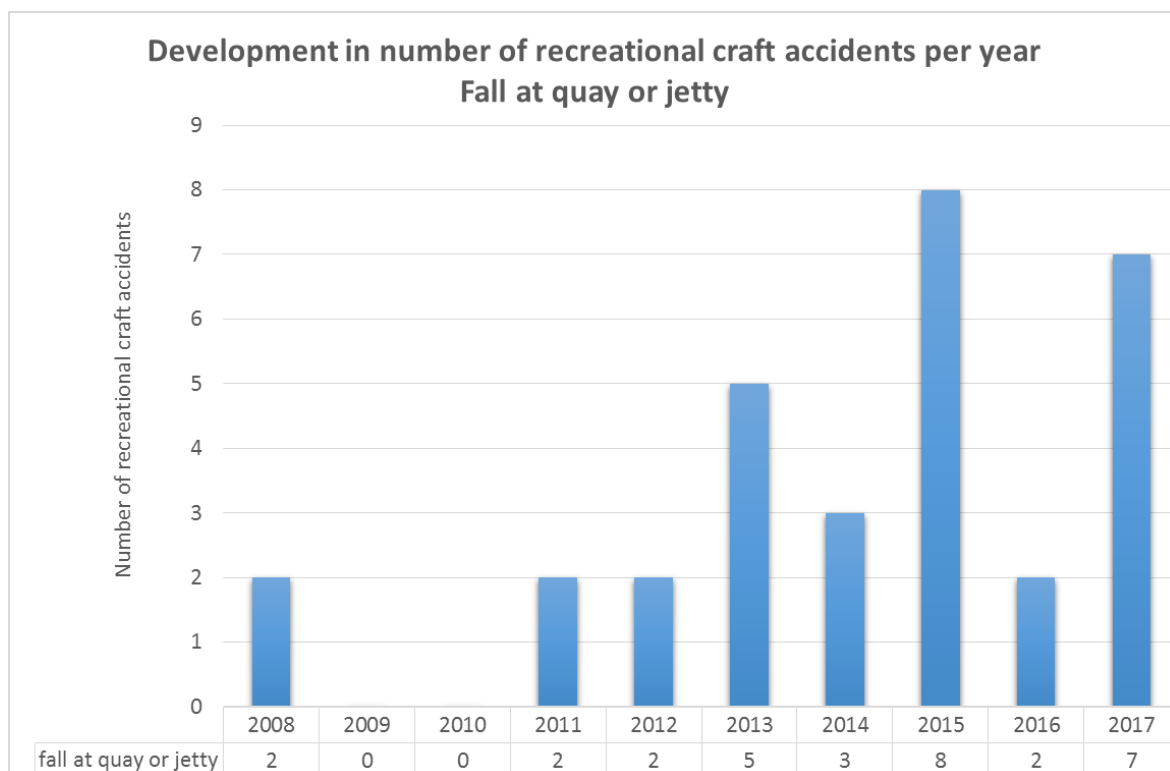
The results could indicate that serious accidents involving falls at quay or jetty are seeing an increasing trend, but there is a great deal of uncertainty relating to these figures.

Figure 16: Development in the number of recreational craft accidents – fall at quay or jetty

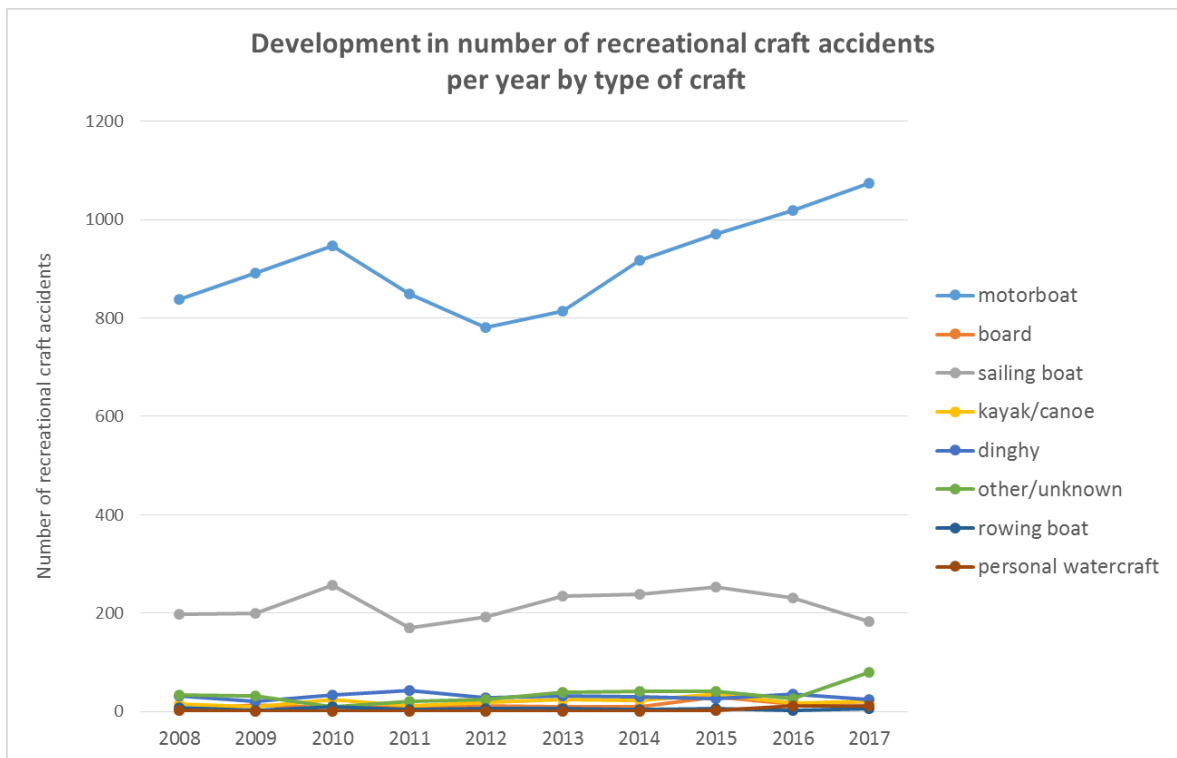
The development in the number of recreational craft accidents per year by type of craft is shown in Figure 17.

Figure 17: Development in number of recreational craft accidents by type of craft

Figure 17 shows that motorboats dominate the number of recreational craft accidents.

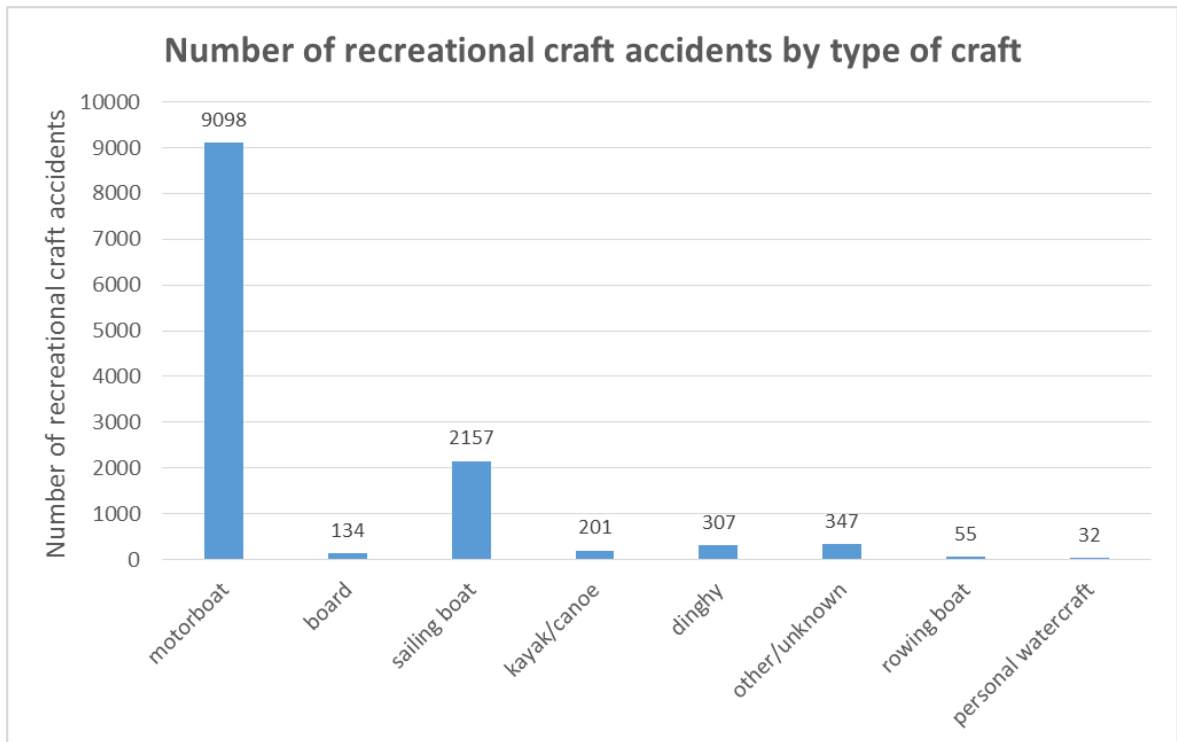
The number of recreational craft accidents broken down by type of craft is shown in Figure 18. The figure shows that most accidents involve motorboats, which is to be expected, since motorboats are the type of craft that dominates the recreational craft segment.

Figure 18: Number of recreational craft accidents by type of craft

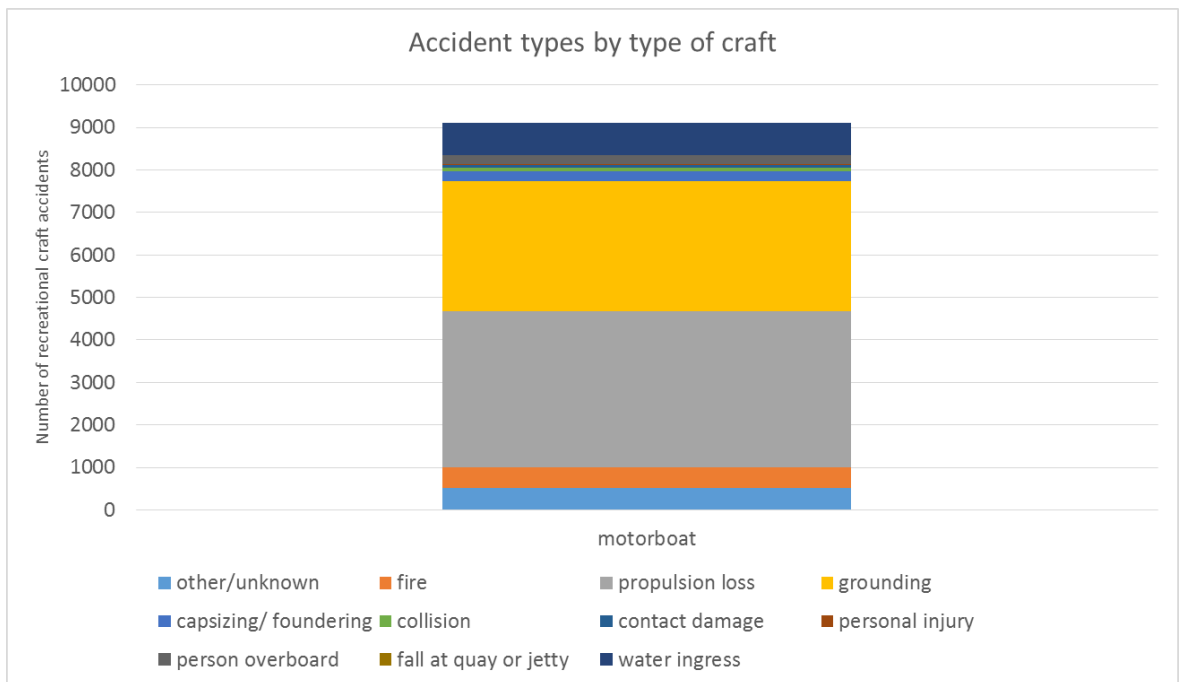
The number of accidents involving motorboats is showing an increasing trend. Propulsion loss and grounding are the most frequently occurring accident types for this type of craft.

Figure 20: Breakdown of accident type for motorboats – 2008–2017

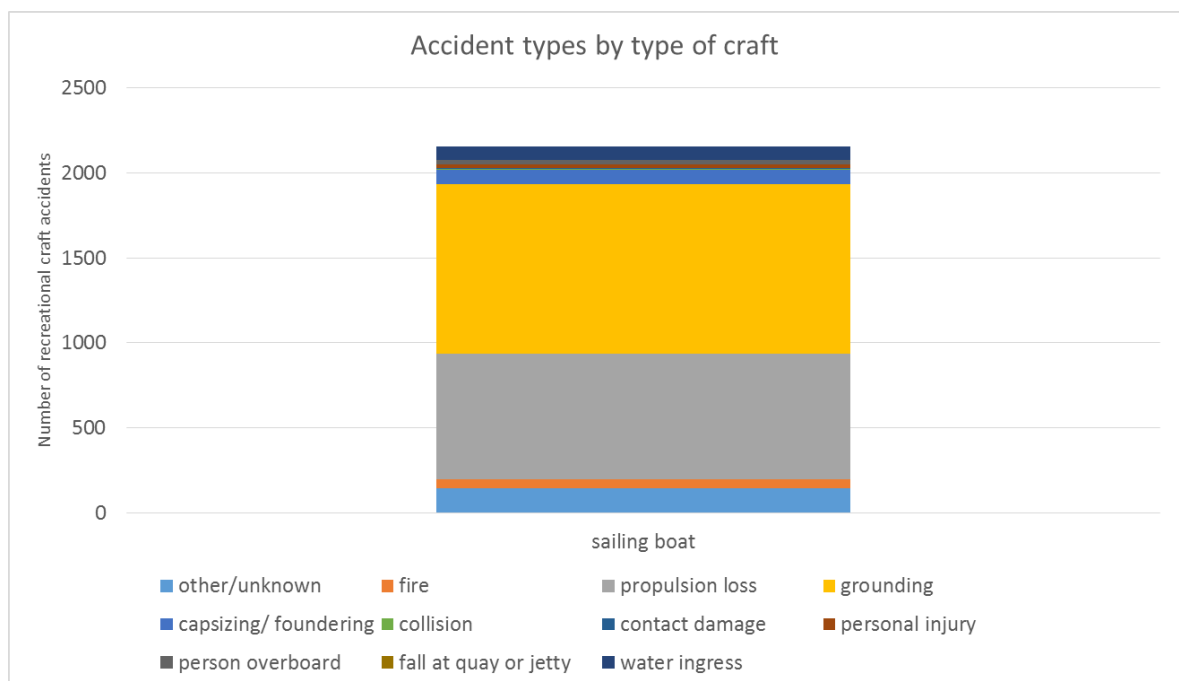
Grounding and propulsion loss are the most frequently occurring accident types for this type of craft.

Figure 23: Breakdown of accident type for sailing boats – 2008–2017
